## **EVALUATION OF LOW VOLUME RURAL ROAD DAMAGE IN COASTAL AREAS OF BANGLADESH**

### **ABSTRACT**

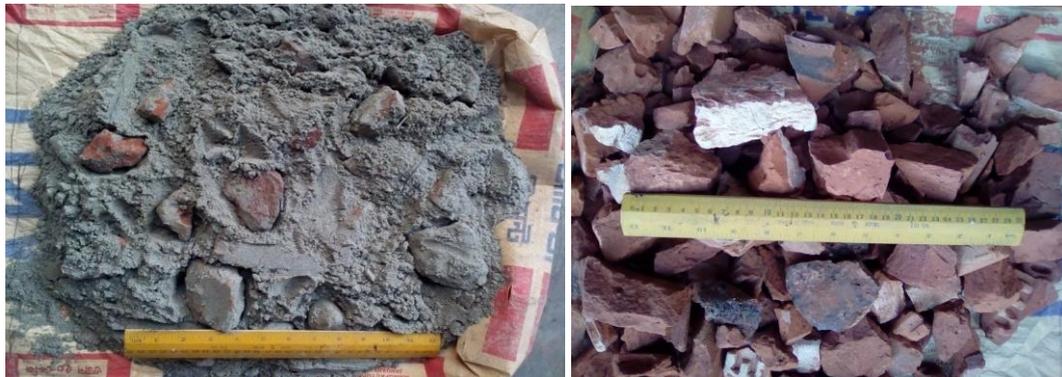
Recommended size of the clay burned brick chips for subbase and base is 38mm down well graded brick chips (Road Design Standards of LGED, 2005). In many cases, it was found that 70% (by weight) of the total brick chips are larger than 38mm (see Figure 5). As per LGED specification, the ratio of the brick chips and sand should be 1:1 in subbase. In such a mixture, the brick chips become isolated and suspended in the fine sand matrix where property of sand dominates in stress-strain behaviour of the mixture. This ratio need to be revised based on experimental study using different mix ratios. In the field, more than 65% fine sand was found in sand-brick chips mixture. In the base, used brick chips are made from 2nd class clay bricks which are not properly burned in many cases. This type of brick chips are easily break-down during vehicle movement resulting rutting at wheel position of the road. These sub-base and base are responsible for rural roads with rutting, a lot of pot holes and damage.

Figure 5: Sub base and base sample collected from kaliganj, Satkhira

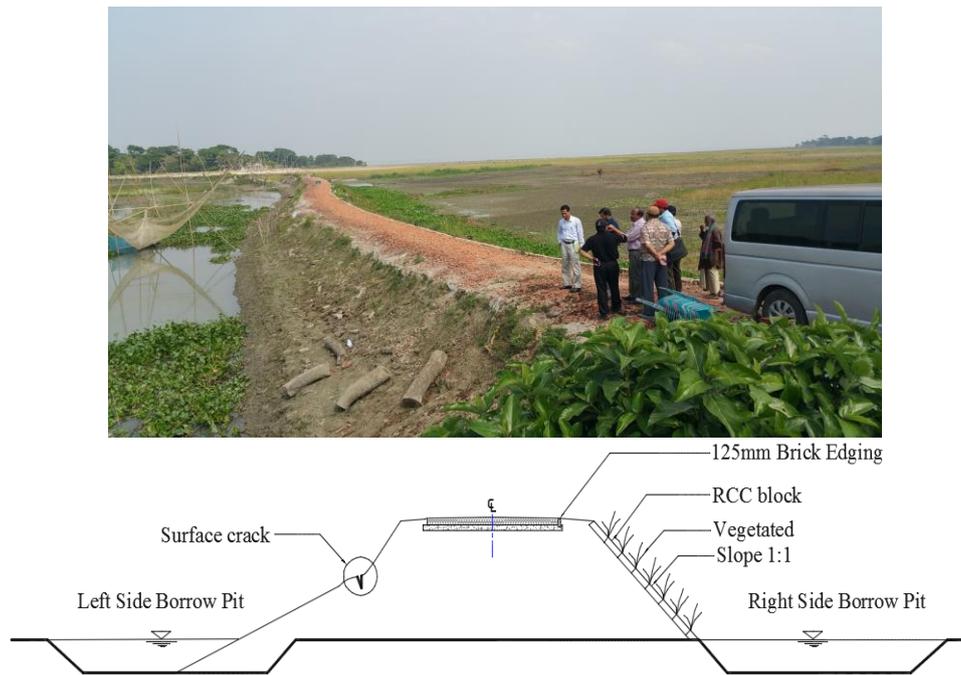
Side slopes of roads were found steeper (1V:1H) than the design value (Rural Road Design Standards of LGED (2005) is 1V:1.5H for clayey soil, 1:2 clayey sand and 1:3 for sand or silty sand). Figure 6 shows a road at Bilaspur, Kaziarchar, Shariatpur. As the slope is steeper and the height of the road is more than 3.66 m, a surface crack was observed on the slope. Due to the steeper side slope and poor compaction, the crack also appeared on the shoulder of the road at Uttarpara, Uzirpara, Barisal (see Figure 7).

Figure 6: Failure line is observed in a road of Bilashpur, Kaziarchar, Shariatpur: Photograph, schematic diagram.

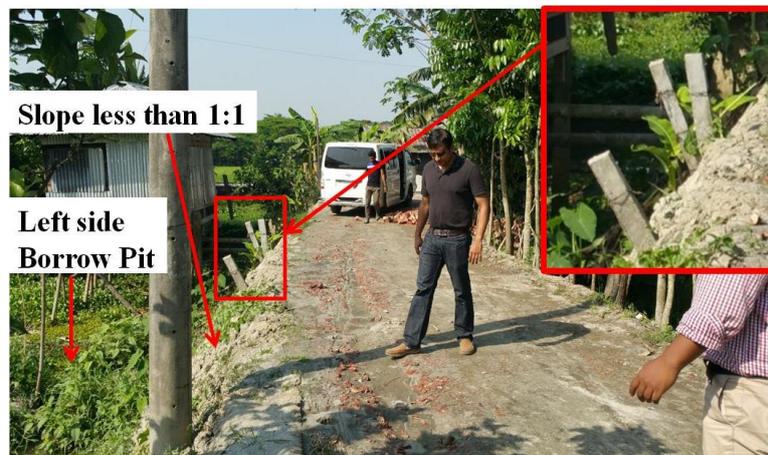
Figure 7: Steep side slope of rural roads in the study area (Location: Uttarpara, Uzirpar, Barishal).

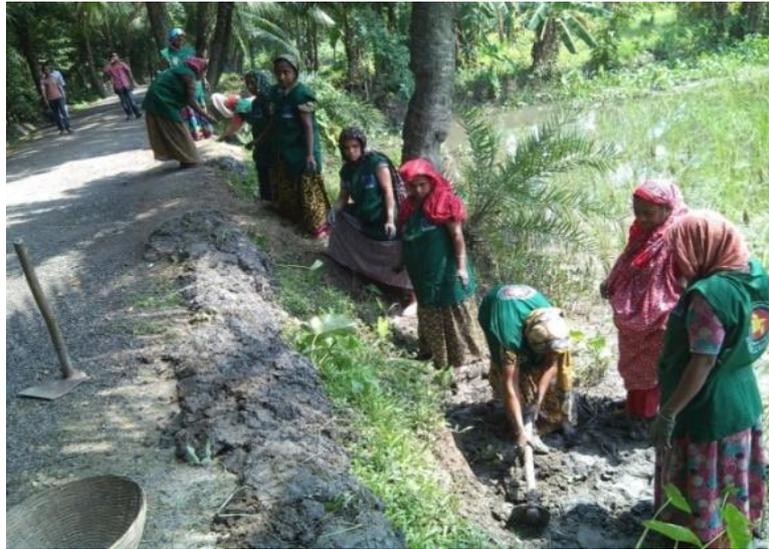
Borrow pit locations were found at the toe of embankment. Borrow pit location should be at least 3 m or 1.5 times of road height (which one is greater) away from toe line (Road Design Standards of LGED, 2005). But in Figure 8, it is observed that the location of the borrow pit is at the toe of embankment. This is a reason of unsustainable rural road.

Figure 8: Borrow pit was at the toe of the road. (Location: Babubazar, Barishal).

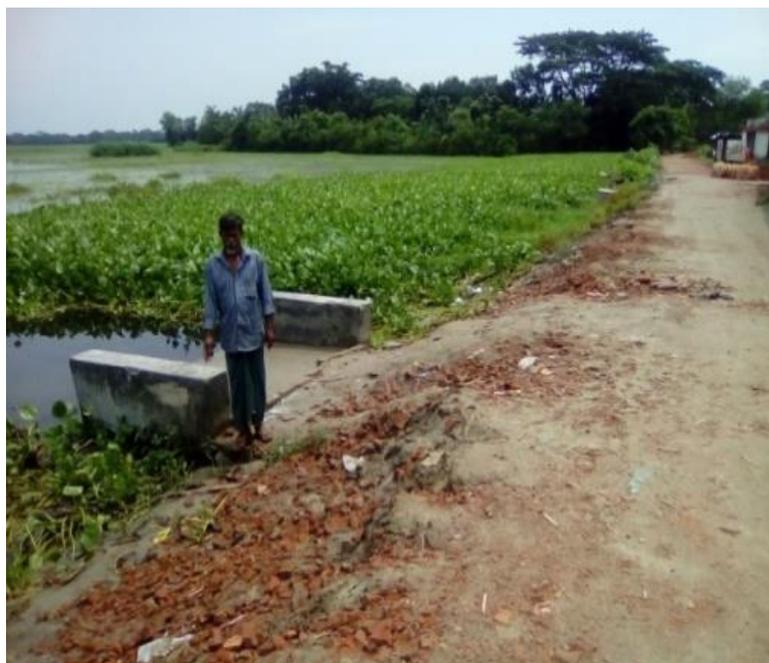
Some rural roads run along the bank of river or khal (Figure 9). This kind of road needs slope protection works for sustainable road construction. Sometimes, slope protection work is done using CC block revetment as shown in Figure 10. This is a typical design which is followed everywhere without any slope stability analysis. That is why sometimes slope failures are observed as shown in Figure 11. Limited fund of rural road construction is a reason of not doing any proper slope protection design.

Figure 9: Road along khal/river

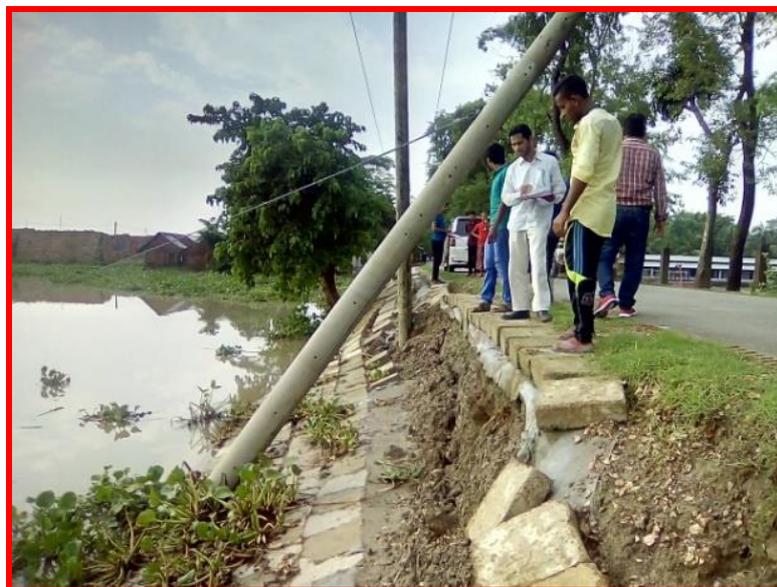
Figure 11. Embankment slope failed.

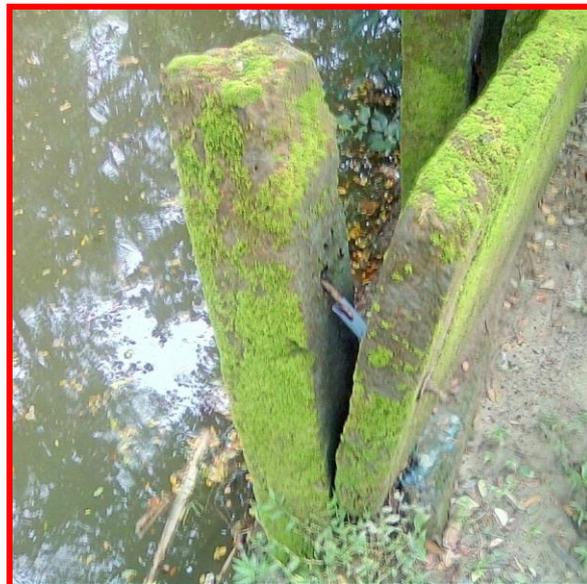
Palisading is done to stabilize the slope. In most of the cases palisading does not work properly. Figure 12 shows the design of palisading followed by LGED. Firstly, the precast piles of 3 m length are driven into the existing soft soil at a c/c distance of 0.90 m. Thereafter the RCC precast plates are hooked using nuts and bolts. After one or two years of construction the nuts and bolts become corroded and slipped from hooked piles (see Figure 13). Besides, in between two vertical RCC plates small gap exist through which the soil washed away day by day and erode the slope (Figure 13). Later this design is modified by LGED. They used cast in place plates instead of precast plates. However, this system is not stable in many soil conditions of coastal districts. The posts are inserted within the soft soil layer. Existing typical design and construction methodology of palisading need to be revised. Palisading design need to be modified with proper stability analysis.

Figure 13: Nut corroded, and Soil washed out in between the plates.

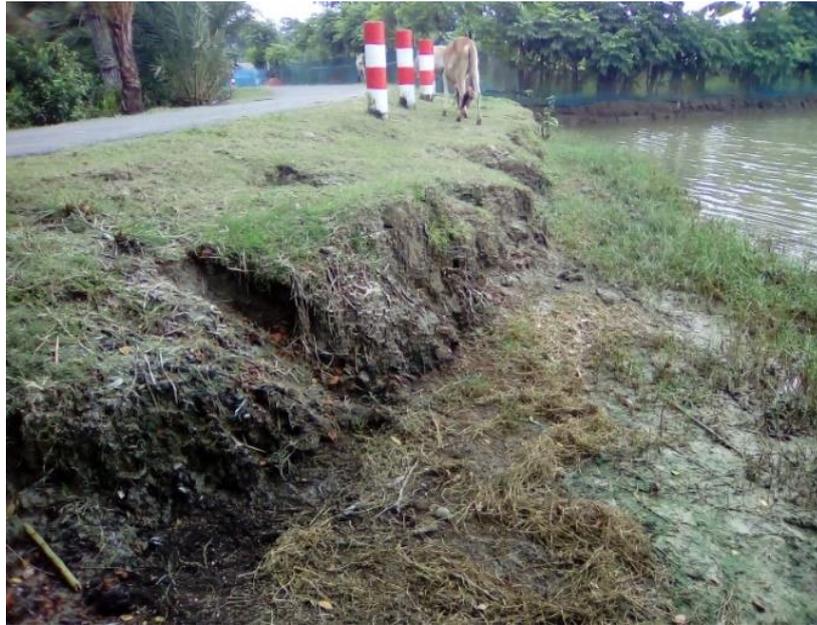
Crab, lobster and other fish farming in the coastal area are very common in Bangladesh. So, in the both side of the road the water exists throughout the year. Due to shallow water, wind generated waves erode side slopes (see Figure 14). In such location, soil is not available for widening and elevating road. To overcome this problem, dewatering of fish farm is done for road construction and

Figure 14: Side slope of rural road washed away by wave action.

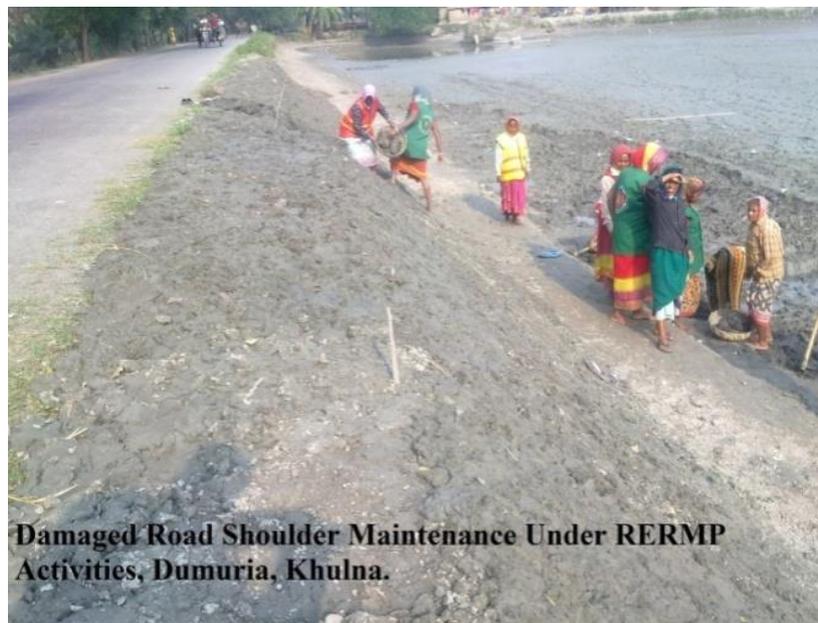
the muds of the fish farms are used for road widening. Figure 15 shows damaged slope repairing using mud of dewatered fish farm. The soil is too wet to compact.

Figure 15: Mud dumping at side slope from dewatered fish farm (Location: Dumuria, Khulna)

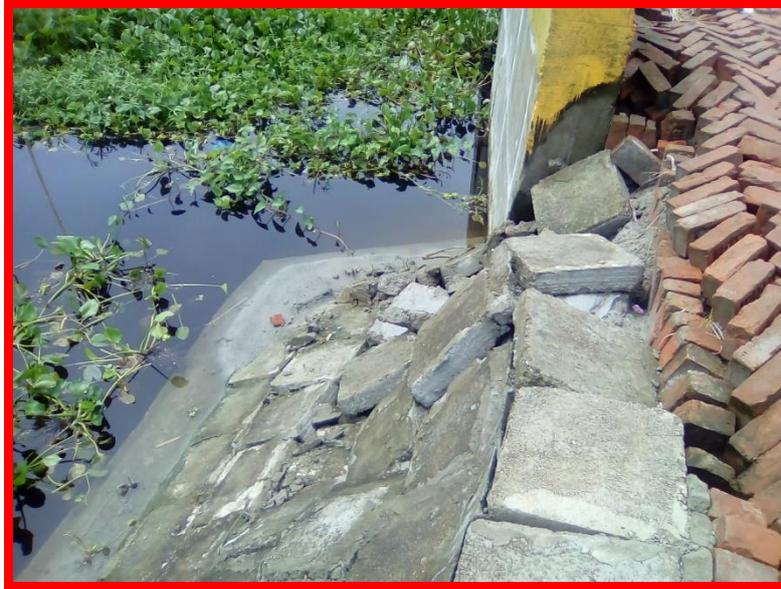
Approach road must be designed and constructed in proper way to avoid differential settlement between abutment and approach road. In Figure 16, photograph are added to show the settlement of approach road. Geotextile and CC blocks were used for slope protection at approach embankment. Consolidation settlement of underlying soft soil, lack of compaction of approach embankment and inadequate wing wall are the major reasons of approach road damages.

Figure 16: Damages of an approach road of a bridge.

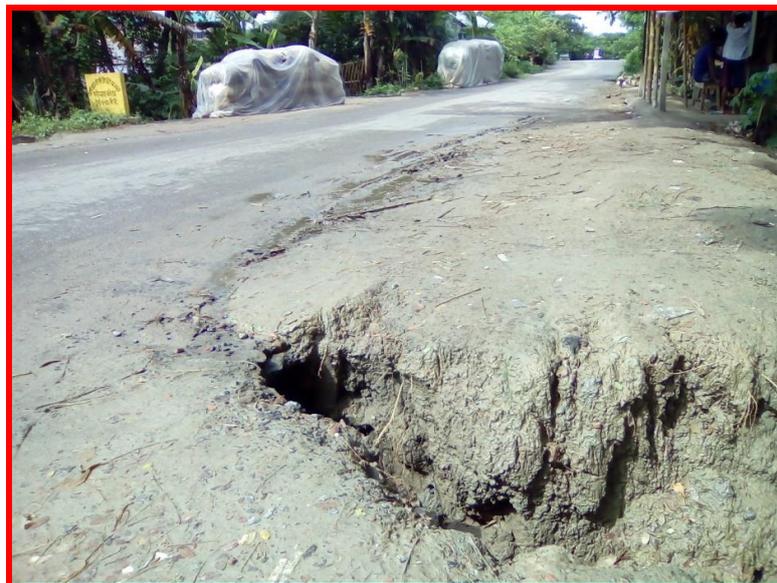
Vegetation don't naturally grow immediately after construction. Bare soil is vulnerable to rain cut erosion during rainy season immediately after completion of construction. Figure 17 shows such a situation.

Figure 17: Rain cut erosion in shoulder without vegetation

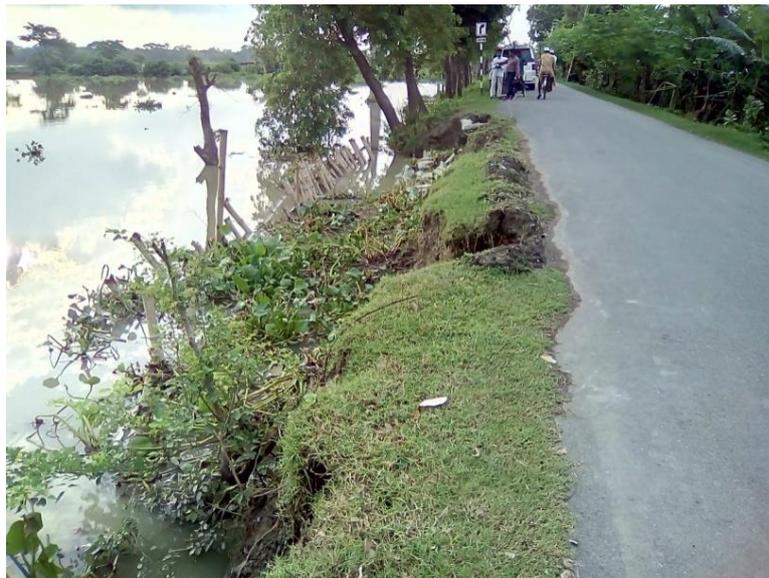
Vegetation is eco-friendly and has a very beneficial effect on the side slope protection. But, due to lack of maintenance and inadequate sunlight, it does not grow properly to protect the slope (Figure 18). Sometimes, deep seated slope circle failure occur which cannot be protected by vegetation only.

Figure 18: Slope failed in a vegetated slope

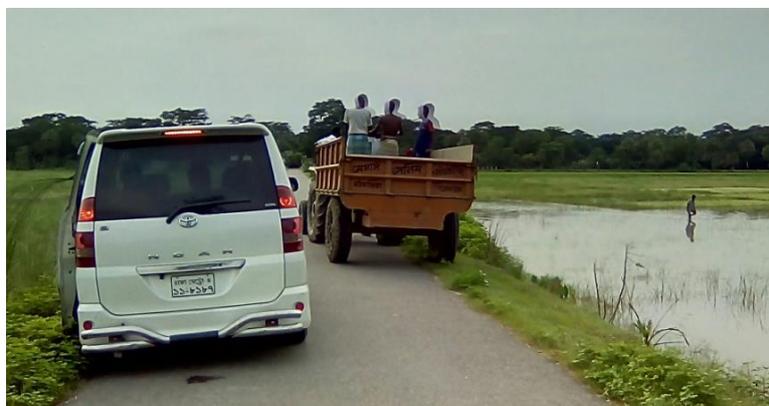
When a road network is developed in rural area, economic activity increases. Some people build multi-storied buildings beside road. So, loaded trucks enter into rural roads for which the road is not designed. During passing other vehicle, wheels of truck go on soft shoulder causing initiation of

damage at pavement edge and shoulder (Figure 19). Because of frequent movement of loaded truck the small damage becomes greater.

Figure 19: Truck position at the edge of pavement and shoulder

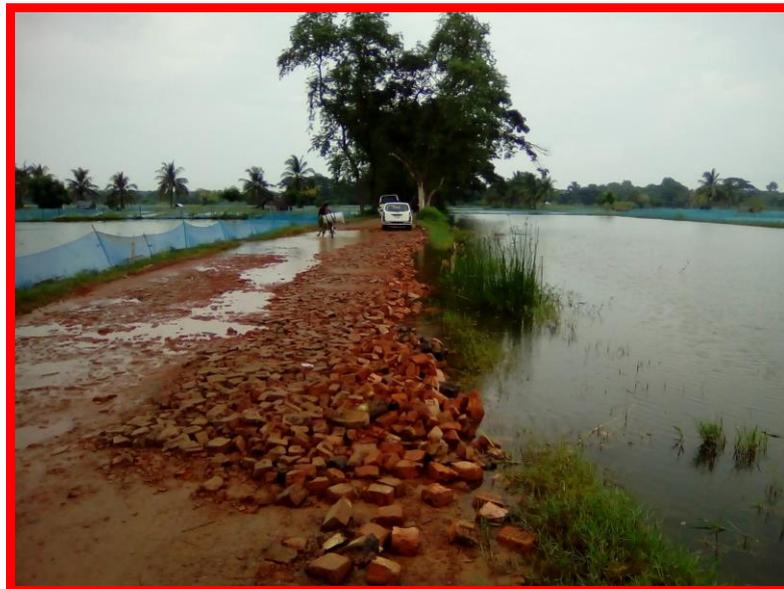
When roads are constructed on this subsoil, consolidation and squeeze out of soft clay cause subsidence, cracking and rutting of constructed road. Subsoil investigation should be mandatory for road project in coastal areas. Special attention should be given in the planning and design phase of road projects. Figure 21 shows the settlement of road on soft soil. In the both sides of the road fish farm is full of water.

Figure 21: A Portion of road settled

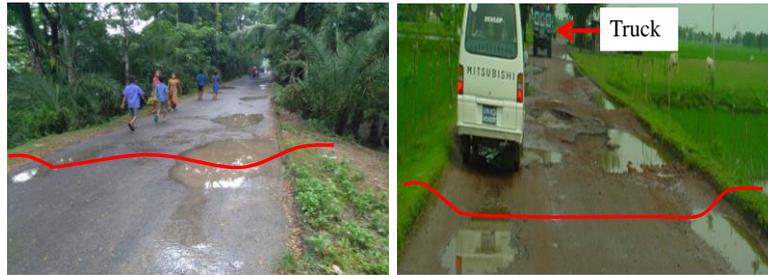
When roads are constructed, crown and 3% lateral slope is maintained (Road Design Standards of LGED, 2005). After one year of construction, rutting and subsidence of pavement create water logging on the road pavement. This water logging damages the bituminous carpeting and subsequently base layer. Two photographs of Khulna region are exhibited in Figure 22 shows the field scenario.

Figure 22: Water logging on the settled pavement and wide spread pot holes

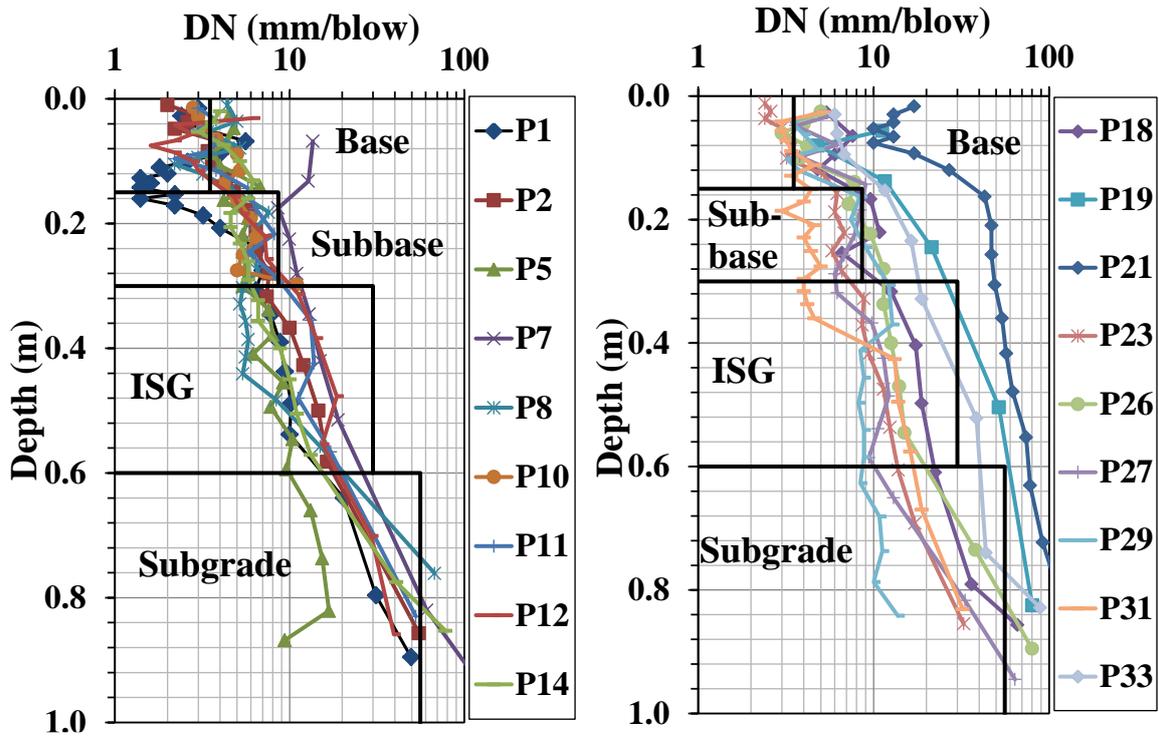
Figure 24. DCP test results conducted on the village road

A digital moisture meter was used to measure moisture content of the subbase and ISG after making a small hole on road pavement. Later it was filled with concrete. Moisture contents of roads were between 14 and 18 percent for subbase and ISG. In the shoulder the moisture content was more than 50 percent. The DCP test data were analysed by using the AfCAP LVR-DCP software (A software developed by Africa Community Access Program). In Figure 26, adequacy of each layer is checked by comparing with maximum recommended DN (mm/blow) values shown in Figure 23. Adequate layers are represented by green colour and inadequate layers by yellow colour. Thus, all DCP tests data were analysed and adequacy of layers is listed in Table 1. In most of the cases, bases were found inadequate. 10 points out of 16 points on shoulder were inadequate. Some sub-bases were found inadequate and few ISG (Improved Subgrade) were found inadequate.

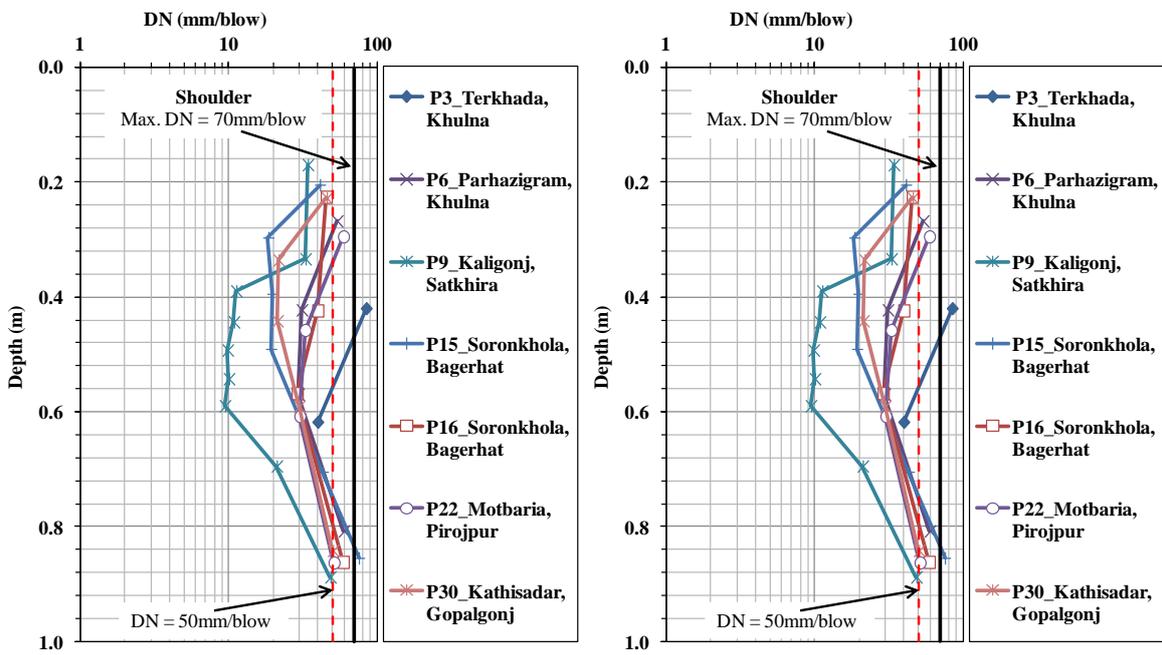
Figure 25. DCP tests conducted on the shoulder of the rural road

Rutting on road pavement may be attributed to inadequate base layer. Initiation of damage at the edge of pavement may be attributed to inadequate shoulder. Shoulder and widened part of road acts as confinement to existing road. Soft shoulder is not capable of giving confinement to pavement layers. That is why authors think that shoulder should be hard type with herring bone brick under which there should be a sub-base layer. Dumping of mud at shoulder and side slope must be avoided to make sustainable rural road.
