Traffic Congestion at Road Intersection due to Absence of Efficient Traffic Management and Planning: A Case Study on Fulbarigate, Khulna

Redwan Kabir ¹, Farhana Kabir Zisha* ² and Moniruzzaman ³

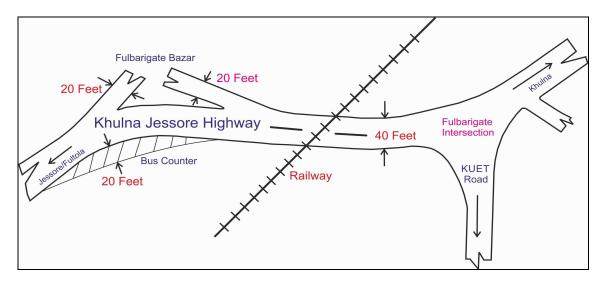
Figure 2: Layout plan of the study area

In general, metaled pucca strip of road meant for vehicular traffic movement is called carriage way. Normally IRC standard of carriage way for a single lane is 3.5 meter including 68 cm of clearance. As in this case, the study area road is double lane the standard carriage way width should be (3.5*4) or 14 meter for two way road. But in practical only 12.22 meter exists.

Median is dedicated to separate the vehicular flow moving in opposite direction to each other. It is also used to direct the traffic flow at a particular space. The existing median is in very poor condition and it is about one feet in width.

The surface of the pavement is very rough which creates greater frictional resistance between the tyre and road surface. The road surface is not smooth and damaged in various points which is very dangerous for a road intersection. Water logging is seen during rainy season and due to roughness of the surface water cannot pass over the road surface.

Camber was provided during the reconstruction of this road few years ago. But due to excess vehicular flow and heavy moving vehicle the crown is damaged at the midpoint of the road surface. Camber is provided for surface runoff. Due to absence of sloping surface runoff is interrupted and there are no proper drainage facility on both sides of the carriage way.

Sidewalks provided for this road is insufficient which cannot supply the demand requirement due to heavy pedestrian flow at this road intersection. The sidewalks are informal and are about two feet of width. Most of them are abused by the on street parking and on street shops as a result people tend to walk over the carriage way which is very risky.

Improvement of road condition is a must for this road intersection. Absence of a specific footpath results in street business at both side of the road and this causes congestion to pedestrian movement. Providing separated footpath, kerb to separate footpath from carriage way, a median to separate two lanes, improving road surface, providing an efficient speed breaker to control the vehicular speed at the point of crossing will improve the overall condition.

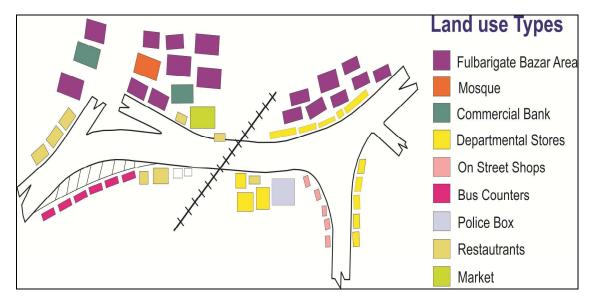
Figure 3: Surrounding landuse pattern

This highway is a very busy road as it severs a mixed use zone. Mainly this is a commercial area. Few banks, a newly constructed market, daily Fulbarigate bazar, bus counters, hotels on street shops and departmental stores are located here. The overall surrounding land use pattern has been shown in the following figure below-

Fulbarigate road intersection is highly dense due to surrounding land use which includes a daily bazar/market, bus stoppage counters and a rail crossing. This is a critical transit point which connects to several district roads.

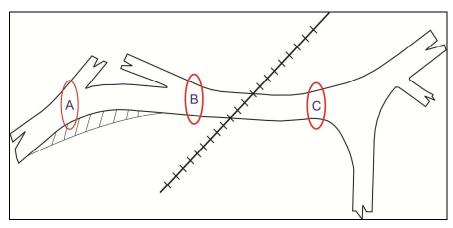
Figure 7: Observation points of pedestrain crossing

In this road intersection there is no specific space for the pedestrian to cross the road or any existing zebra crossing. A huge no. of pedestrian cross this highway which is too risky and often slows down the regular vehicular speed. From the field survey we see that point C is the most used crossing point and it is a must to

provide a zebra crossing in there. We can also see that during the evening hour the pedestrian movement is very high comparing to the other time of the day. The major crossing point A, B & C are shown below in figure 6:

Due to opposite location of residential zone and daily bazar people need to cross the road frequently to get their required goods. Lack of zebra crossing and foot over bridge along with proper systematic approach is the main cause of frequent pedestrian crossing resulting reduction of design speed of the vehicles. Three observation points were selected for the determination of the frequently crossing zone that needs proper safety measures and attention for a systematic pedestrian crossing. The peak hour of heavy pedestrian flow and crossing is at 6 to 7 pm in the evening.

From the figure above the important crossing areas were identified at A, B and C. These points needs efficient safety measurement as user friendly crossing services. In this regard zebra crossing should be provided for safe crossing of the pedestrians. It should be noted that crossings should appropriately sited with respect to the road geometry, i.e. avoid bends, departure sides of crests. Motorist parking too close or on a pedestrian crossing should be prevented. It is beneficial to both the users and the installing authority because of relatively low cost installation and less delays to motorists than signalized crossings. The width of painted lines on zebra crossings range between 3 m and 6 m; MRWA standard is 3.7 m. For crossings without kerb protrusions, parking must be restricted for a minimum of 20 m on the approach and 10 m on the departure side of the crossing to achieve minimum sight distances. (Planning and designing for pedestrians: guidelines)

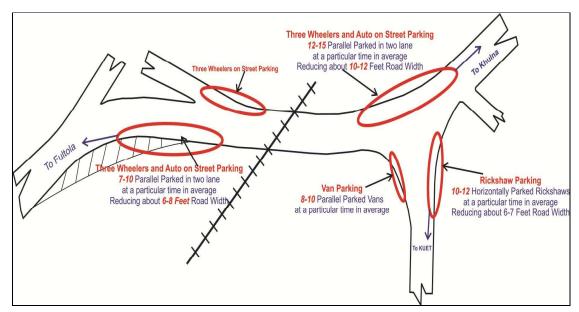
Figure 8: Onstreet parking locations with number of vehicels parked in average

On street parking in this highway is a common phenomenon. But drivers follow no rules in maximum case. Parking at the points of road intersection, on street parking of vehicle in two bays, parking vehicle in a wrong manner is most common scenario. Parking volume in road intersection is given below in figure 7:

in terms of vehicles moving just behind the stopping passenger vehicle often cause accidents at this point. Two occurrences has been observed in recent times regarding this fact (Field Survey). In this study four problematic areas were selected which reduces roadway width by on street parking. The total roadway width is 40 feet but due to unsystematic on street parking this becomes 25 to 30 feet at the road intersection which creates problems for heavy vehicles like buses and trucks to pass between them. In addition, parking of slow moving vehicles like rickshaw and vans on the curves of merge and diverge act as an obstacle to the merging and diverging vehicles. There are about ten to twelve rickshaws and eight to ten vans parked on average in the major intersection leading to Jassore bypass road reducing roadway width about five to seven feet. Due to lack of insufficient space for parking this causes congestion in this intersection.

To avoid collision at this point of intersection as well as to maintain regular traffic flow parking rules and monitoring should be imposed strictly. On street parking in several lines should be prohibited. Parking of three wheelers in the parking lot should be banned to ensure parking facility to buses. Parking lots for the vehicles should be specified. Horizontal parking of rickshaw and at the point of intersection which most common in this case study area should be banned and maintained strictly. On street business at the parking lot shown in the figure and the shoulders of the road should be strictly prohibited to ensure enough spaces for parking. Getting passengers on road and delaying for 5 to 10 minutes should also be prevented. A specific parking space should be provided for the three wheelers nearby. Parallel parking by rickshaws and vans should be followed. To reduce unnecessary parking tendency of drivers a small amount of money can be charged to park for per hour.
