TESTING OF RCC BEAMS EXPOSED TO VARIOUS BURNING TEMPERATURES

M. M. Hossain*¹, N Apu², U. H Sumaiya³ and Y Mahmood⁴

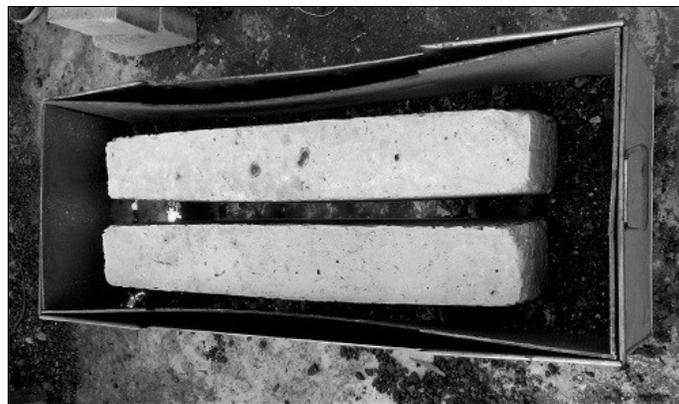
The beams were burnt inside the furnace constructed. Two types of coal, wood coal and stone coal of ratio 2:1 respectively were used for burning. A sand layer having 0.5" thick was placed on the bottom of the shell to restrict the heat transmission. Then approximately 2.5" layer of coal was placed on the sand layer. Continuous air blow was applied to keep the coals burning and to attain and control desired temperature level. The beams were placed inside the shell over two fire clay bricks, and the coal around the beams were burnt. Two beams were

Figure 2: Burning of beam inside the furnace

Burnt simultaneously. Two beams were burnt at 400°C, the next two beams were burnt at 600°C and the last two beams were burnt at 800°C. The sensor of the thermocouple was placed in the gap under the beams to measure the temperature of fire and after each ten minutes temperature readings were recorded. The beams in pair were burnt for two hours after reaching the desired temperature levels. After burning, the beams were taken out of the furnace by hooking the anchor rods and were allowed to cool naturally up to room temperature. Range of temperature and duration of burning followed in this study were also followed by other investigators (Kadhun, 2013), (Ashok & Arun, 2013)

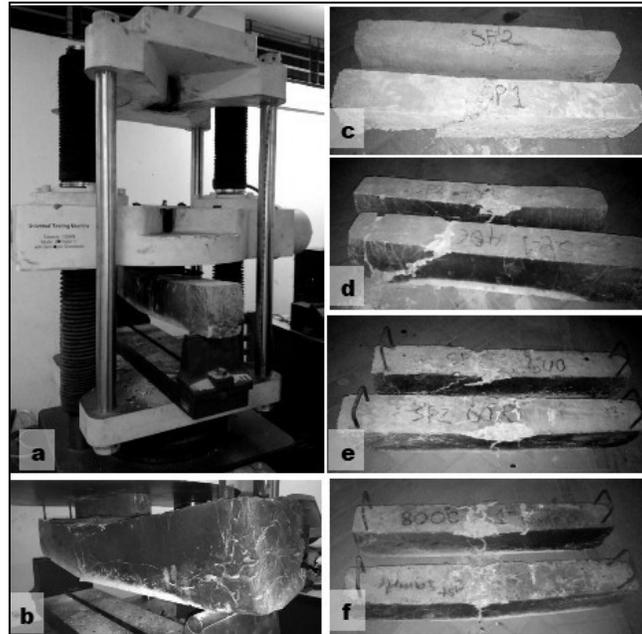
To obtain pure flexural failure, two point load testing was carried out. All the beam specimens were cured in a curing tank for 28 days & then tested. Two unburnt reference specimens were tested for the flexural strength using UTM and the results was recorded. The burnt beams were tested in the same way. The load was increased gradually till the failure occurred in a typical fashion. The loads on appearance of flexure and shear crack along with the failure load were recorded. Figure 3 shows the setup for bending test in an UTM along with the samples after tests. Details of beam reinforcement and loading is shown elsewhere (Apu etal, 2014).

Figure 3: a) UTM setup for Bending test, b) Typical beam at bending, c) Un burnt beams, d) Beams burnt at 400°C, e) Beams burnt at at 600°C, and f) Beams burnt at at 800°C.
