INFLUENCE OF SALT EFFLORESCENCE ON RENDERING MORTAR OF BRICK MASONRY WALLS

M. R. Karim¹, M. H. Islam^{*2} and S. Y. Morshed³

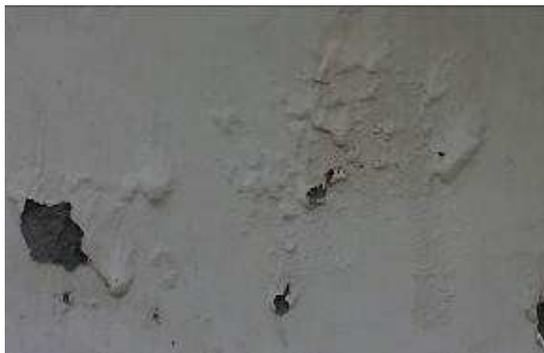
Figure 1: Efflorescence on (a) rendering wall (b) brick masonry wall

Efflorescence has been a major problem for many years in the surface of a masonry wall and rendering mortar. Efflorescence is the crystalline deposit of salts which initially produce a white thin film on the surface of masonry or plaster. It often occurs on masonry façades, and depending on its intensity, changes the colour impression and appreciation of the facade as a whole (Harold & Timo, 2004).

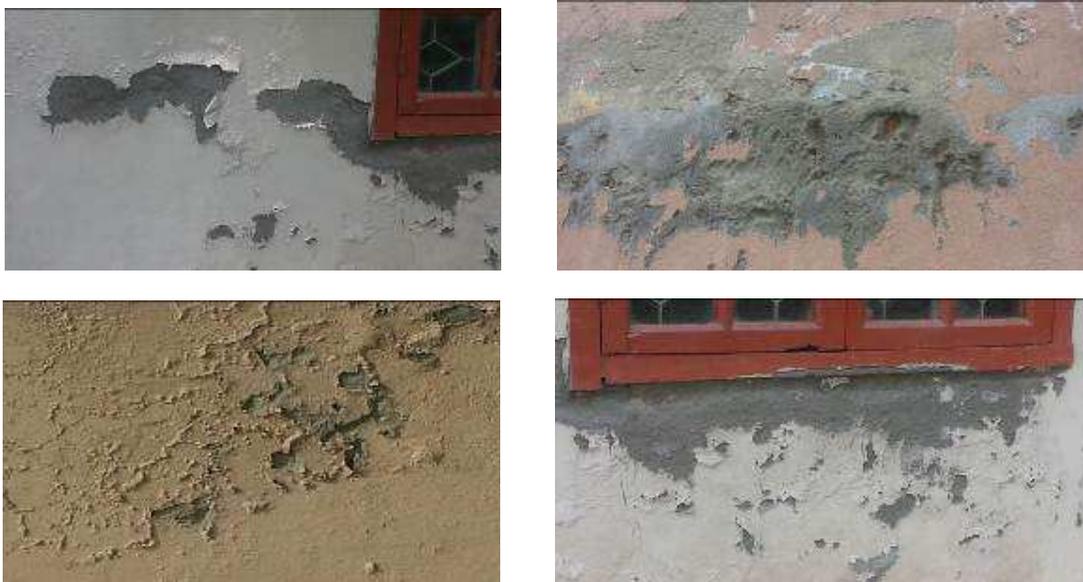
Figure 4: Some picture taken during field survey showing decay of mortar

A total twelve building were surveyed and salt decayed area was estimated using equation (1). The floor plan of the studied buildings was collected from Planning and Development section of KUET. The exposed surface area was then calculated by multiplying the periphery of the floor plan with height of each floor. Then the result was presented as percentage of affected area of total ground floor surface area and also of total exposed surface area of the structure.
