AN EXPLORATORY STUDY OF WATER QUALITY DUE TO WATER LOGGING AND DRAINAGE CONGESTION IN THE BHABODAH AREA

Ananya Sarker*¹ and Khondoker Mahbub Hassan²

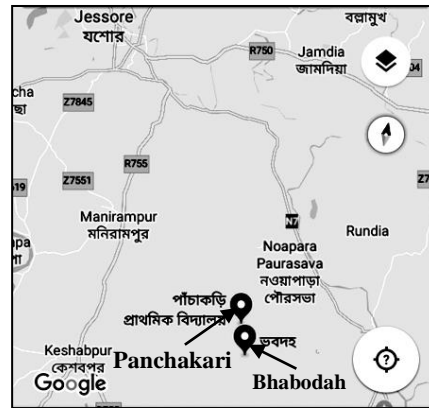
Fig.2: Selected affected area adjacent to Bhabodah

The research related field work was conducted at Bhabodah area of Jashore district located in the south-west region of Bangladesh within Khulna division shown in figure 1 & 2. To investigate domestic water supply and sanitation situation, 8 water samples in dry and water logged condition and 3 wastewater samples in waterlogged condition were collected from mostly affected community in Bhabodah, named 'Panchakari'. Collection, transportation and storage of water samples will be done following laboratory standard methods. And then some improvement options for water and sanitation system were proposed. Various physical, chemical, and biological water quality parameters were tested in 'Environmental Engineering Laboratory' at KUET.

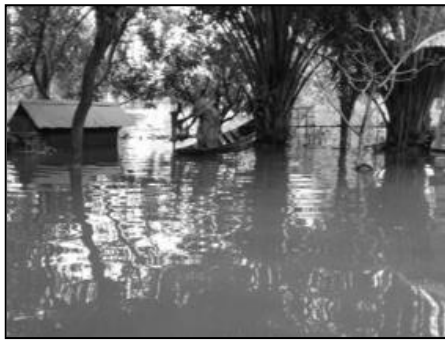
Fig.3: Water logged condition in 2016

Field investigation was made to know previous and present conditions of the study area. Water rose about 2-2.5 ft above ground during floods in last years. Most of the people of Panchakari village usually take shelter in Panchakari Primary School for about 6 months or more during floods. Tubewells and pit toilets get inundated and become unusable. About 2-3 nos. of temporary latrines and shallow tubewells had been constructed by the Govt. Authority. People use pond water for cooking and shallow tubewells for drinking purpose. In 2018, for river dredging and not for raining so much, water level rose only upto 2.9 mMSL while in previous years a maximum of 4.0 mMSL.

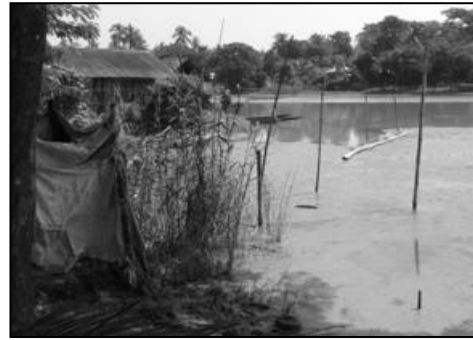
Fig.4: Water logged condition in 2018

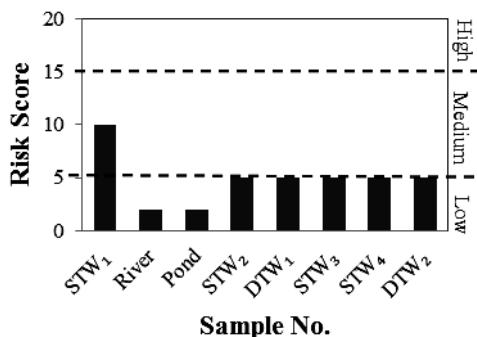
Fig.5: Risk assessment graph for Fe

By using risk assessment matrix in table 1 & equation (1), risk level is analysed for all the samples and is represented as in figure 5 & 6. STW₁ shows highest risk level (Medium) for Fe in both seasons. Again, in fig.6, risk level of all the samples except river & pond water in waterlogged condition rise significantly for the presence of waste water from nearby pit toilet and different garbage. And in both seasons, it is very likely to contaminate river and pond water on regular basis with pathogens that could result in spreading of water-borne diseases among residents of the community. It is also observed that risk level of tube well water samples rise from low to medium. So people should be conscious for using pond & river water, especially for all the drinking water sources during water logged condition.

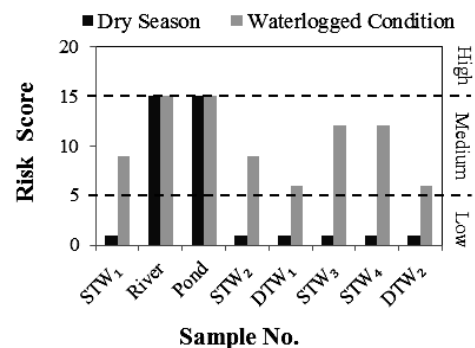
Fig.6: Risk assessment graph for TC/FC

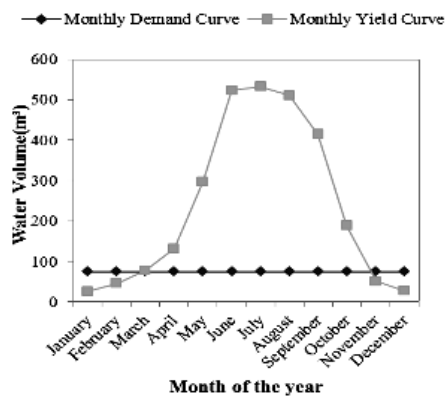
Fig.10: Water demand vs. potential supply curve

Considering 50 household as a cluster, total study area can be divided into 10 clusters. If per cluster has 250 person and 10 lpcd water is used for drinking & cooking, then monthly demand will be 75 m³ (using equation 2). Assuming total roof area is 2500 m². So by equation 3, monthly yield can be calculated and by using these calculations, graphs can be drawn as following fig. 10 & 11.

From the calculation, water demand & rainwater supply curve are drawn in fig. 10. In fig. 11, cumulative Monthly Supply is 2826.25 m³ & cumulative Monthly demand is 900m³. From the data found in graphs, required storage volume in rain water harvesting system can be calculated in table 6.

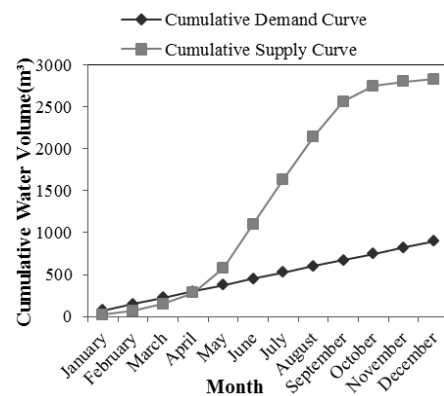
Fig.11: Cumulative demand vs. supply curve
