PERFORMANCE OF GEO BAG AND CEMENT CONCRETE BLOCK TO PROTECT RIGHT BANK OF PADMA RIVER AT SHARIATPUR DISTRICT

Kazi Furkan Hossain*¹ and Md. Jahir Uddin²

¹*M.Sc. Student, Department of Civil Engineering, Khulna University of Engineering & Technology, email: kazifurkance@gmail.com*

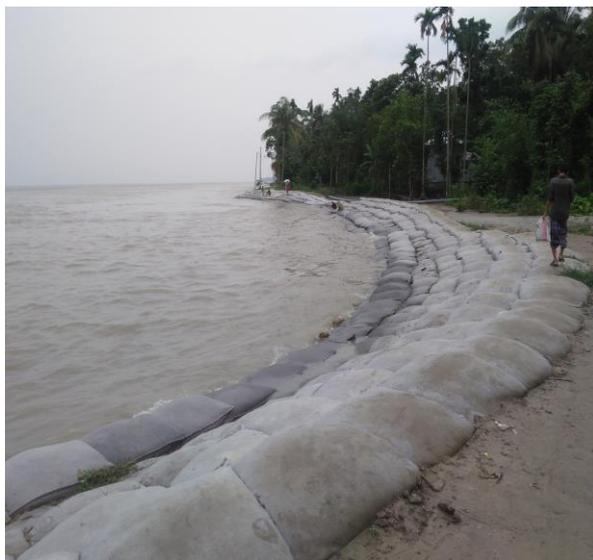
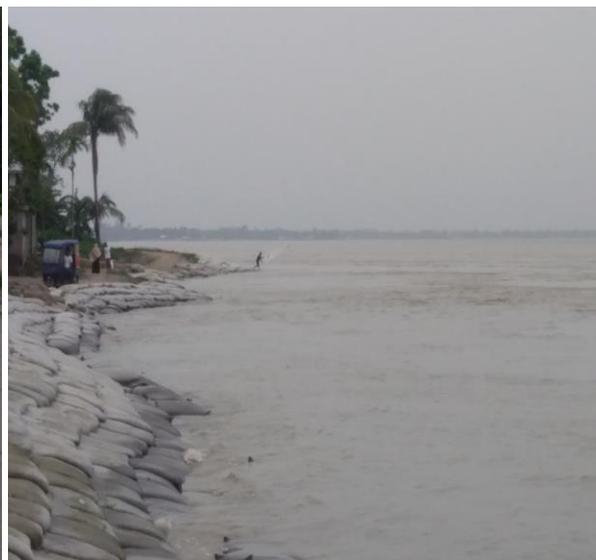
Figure 2: Primary stage of Geo Bag Filling
Mulfatganj, Shariatpur district (10 March 2000)

Figure 3: Final settlement of Geo Bag Filling
Chandipur, Shariatpur district (05 March 2001)

In the figure 2 & 3 it is shown that the Initial and Final position of geo bag. The position of geo bag have been changed due to wave action of water. Sometimes geo bag damages due to environmental effect.

If sand filled geo-bags are dumped only under the water or they are covered with sand after placing in the river banks then they may last for 10 to 50 years whereas they may not sustain more than two years if they are dumped in the open air or partially in the air and water. In our country geo bag dumping in the sun and monsoon is very regular practice. In dry periods when the water levels in the rivers drop down, geo-bags get exposed to the open air though it was placed under the water during monsoon. Also covering the geo-bags with sand after placing in the field level is not feasible which leads to reduced life span of geo-bags.

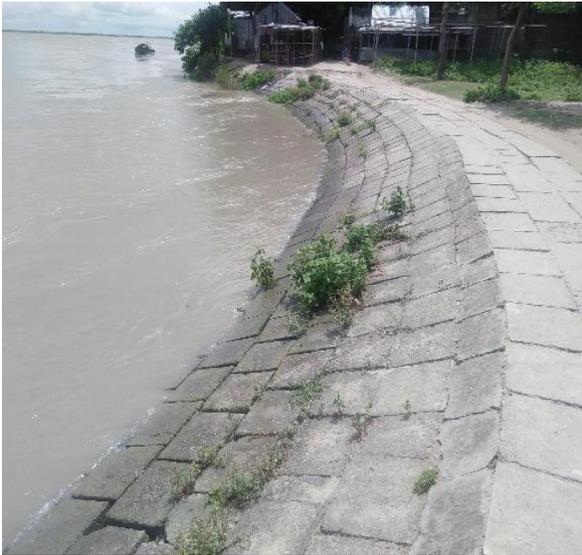
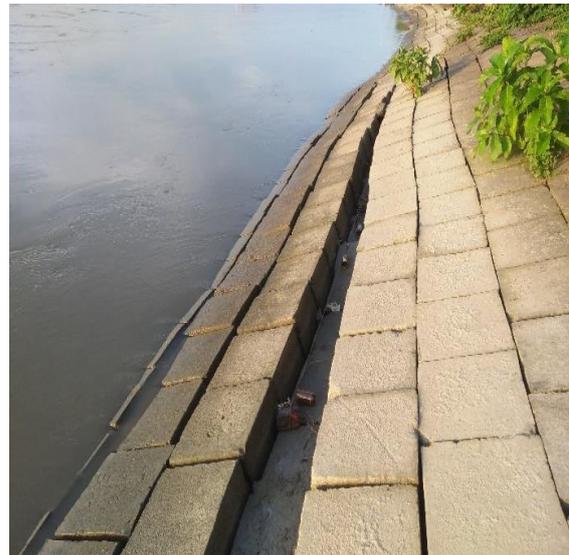
Figure 4: Primary stage of CC Block, Shuressor, Shariatpur District (15 November 2000)

Figure 5: Final stage of CC Block, Shuressor, Shariatpur District (15 November 2006)

In the figure 4 & 5 it is shown that the Initial and Final position of CC block. Although the cost of manufacturing and installing CC blocks is high, it will yield good results in the long run. So it can be said that CC block is better than geo bag in terms of longevity as a bank protective materials.

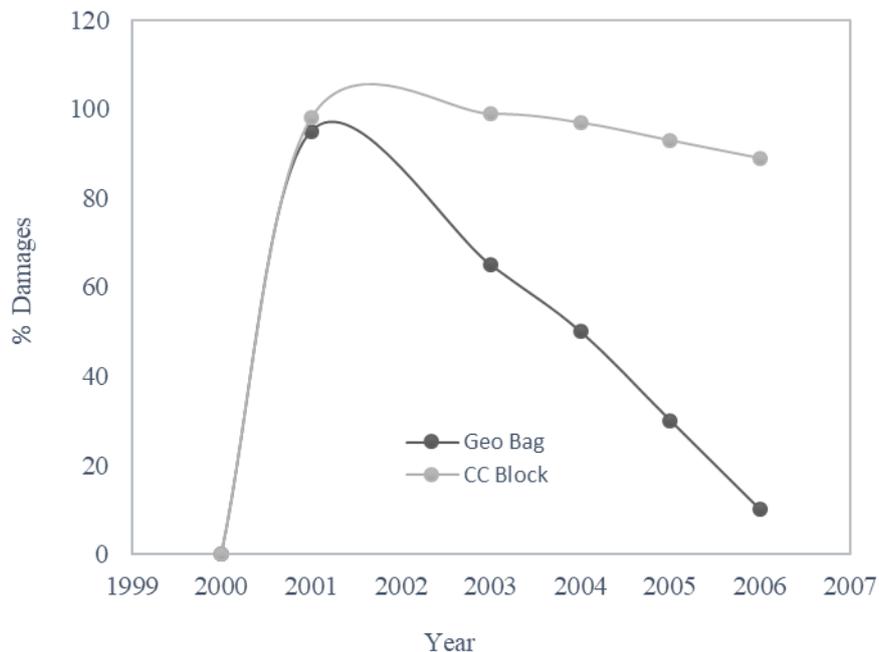
Figure 6: Percentage damages of CC block and Geo bag

Figure 6 presents that the performance of CC Block and geo bag varies over time. It gives effective results for protecting riverbank protection works. One of the main benefits of concrete blocks is its longevity. Concrete blocks are infected with high pressure and vibration, which makes the blocks very strong and able to withstand high levels of load. Concrete blocks are easy to install due to their uniform size and shape. Concrete blocks are very environmentally friendly.

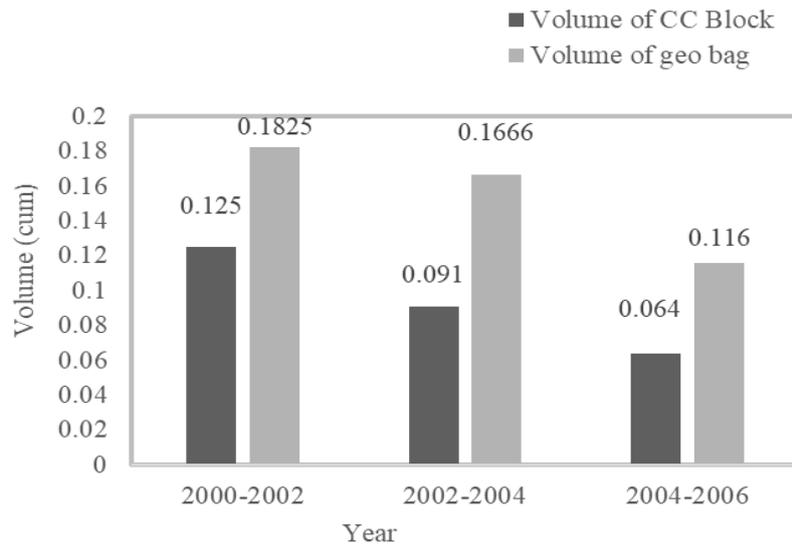
Figure 7: Volume of Geo bag and CC block

In the figure 7 shows that the comparison between volume of geo bags and CC block.

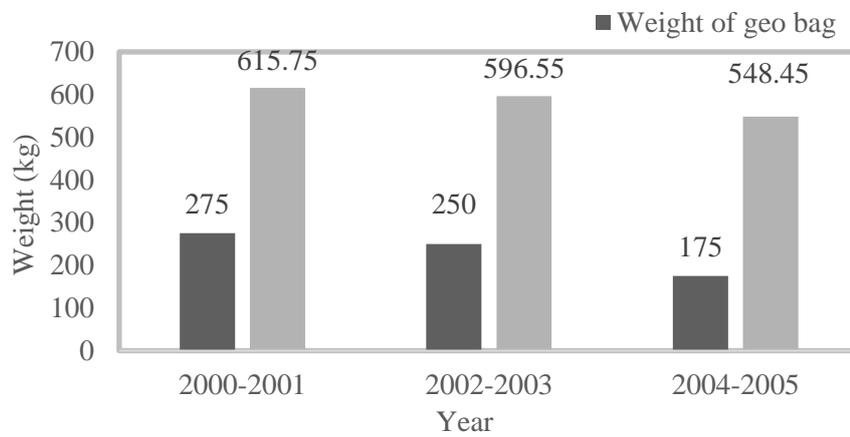
Figure 8: Weight of Geo bag

In the figure 8 it is shown that the changing condition of geo bag and CC block with rate.

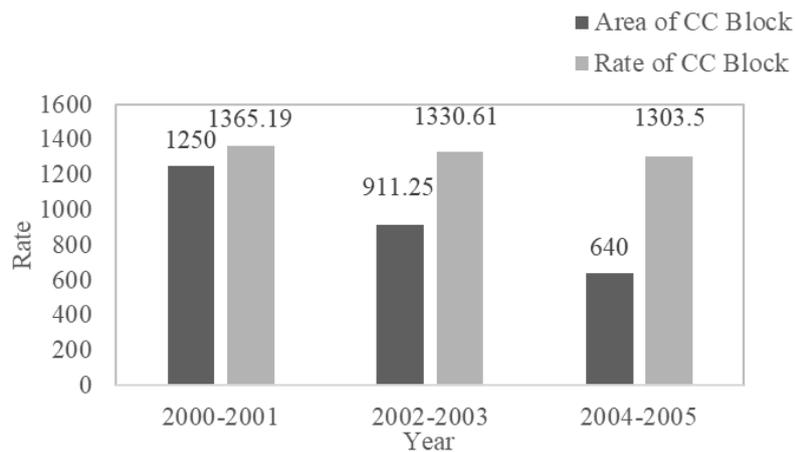
Figure 9: Rate of CC block

In the figure 9 it is shown that the rate of CC block depends on its size. Although the CC block rate is very high, it gives a good and effective result for defending bank security operations. Concrete blocks popularity as a bank protective materials increasing day by day.

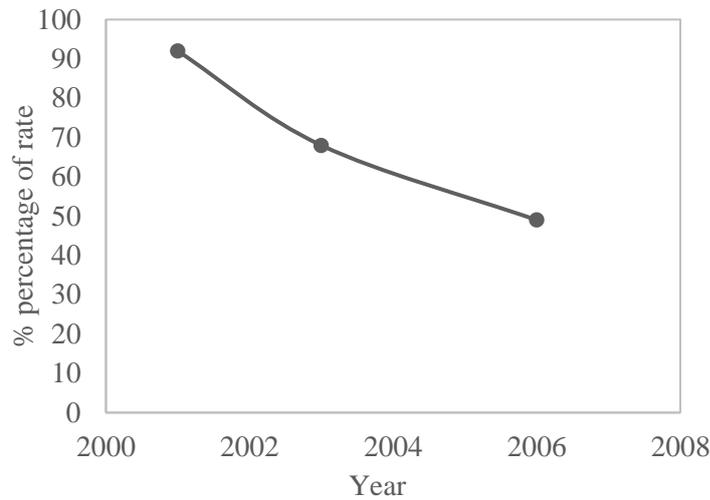
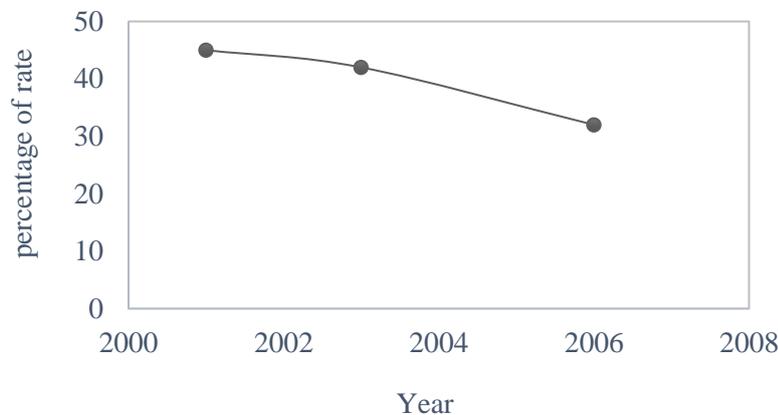
Figure 10: Percentage rate of Geo bag

Figure 11: Percentage rate of CC block

In the figure 10 & 11 it is shown that the percentage rate of geo bag and CC block. CC block has been considered as the longevity of most of Bangladesh's projects related to riverbank security.
