RETHINKING THE STRUCTURAL INTERVENTION TO REVITALIZE URBAN HERITAGES IN THE CONTEXT OF KHULNA

M.R. Khan*¹, N.Sarkar² and S.A. Tisa³

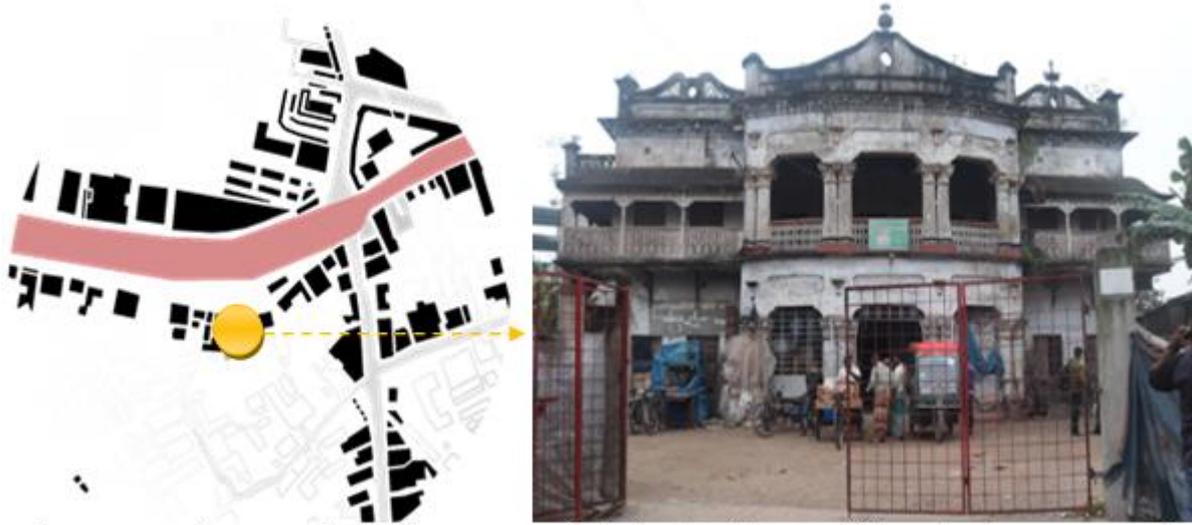
Figure 3: Location map of Agrani Transport Limited and existing conditions (Author constructed, October 2021)

Limited. It located near Dakbangla More, is one of the authentic amalgamations that fully satisfy this method in several aspects, among many others in Khulna city. This structure is positioned as a thriving business district in Khulna. Upper Jashore Road is the main route that connects this site to the rest of the city, creating a hierarchical location within Khulna. It has high land value and tremendous economic and socio-cultural pull due to its location in such a magnet space. This situation warrants more investigation and debate due to its unique significance. Figure 3 shows the location map of Agrani Transport Limited and existing conditions.

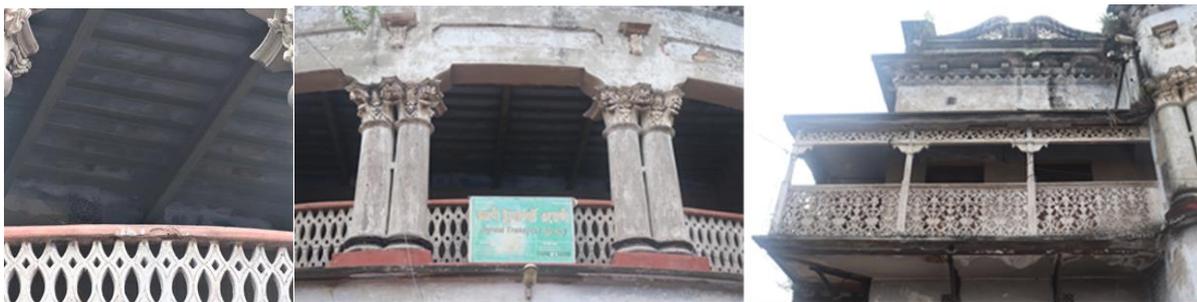
The absolute symmetry of this built form provides a geometric feature itself. The principal construction materials are brick, concrete, and wood with a one-way slab, contextually known as Kori-Borga roofing. The lime-surkhi mortar rests on wooden beams in this form of roofing, known as Kori- Borga which is addressed in figure 04. It originated from Kolkata. This system of roofing got applied by the masons of old Kolkata to construct flat roofs. As a result, the masons spaced the Koris (slender wooden pieces) closely together to rest above broader 'Borgas' (wide wooden sections stretched crosswise in opposite or perpendicular directions to the Kori).

Figure 2: Kori-borga roof (left-side), Structural features of Agrani Transport Limited (Captured by Author. October 2021)

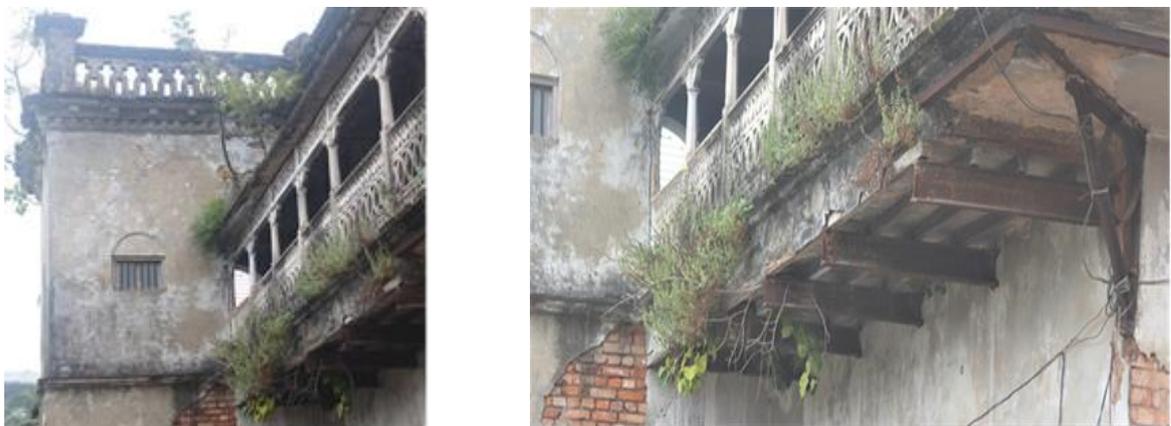
Furthermore, the biological colonization cannot go unnoticed. Some random plants keep growing in the cracks and crevices of the building and establish there encouraging the structural vulnerability to a great extent. Therefore, it also promotes other bacteria and fungus to invade the structure. This is surely a perspicuous case of the lack of maintenance.

Figure 3: Biological colonization (Top), Timber supports on roofing (bottom) (Captured by Author, October 2021)

Because of the presence of rain water, roof timber elements, particularly in the area of their supports, are the most prone to microbial infection. Caused by water penetration through the walls, the support zones of timber sections on roofing are frequently a source of moisture. Metallic 'I' bars has later been added to support the extended roof. Further issue to consider is the inevitable corrosion of steel and wrought iron components installed in masonry components that might cause such elements to collapse owing to the rise in volume generated by the oxidation.

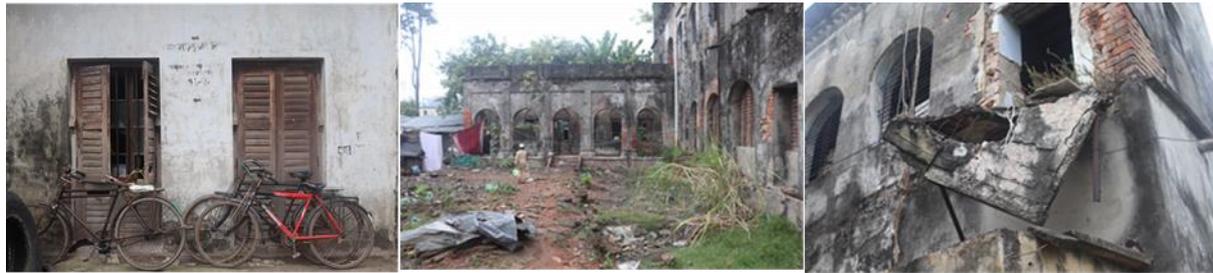
Surprisingly, the wooden Jalousie windows are still fine and in use spontaneously. This depicts that in this particular climate, specific types of woods are better survivors than the exposed untreated bricks. The front façade of the building is still giving off a sense of the gigantic British Colonial period. But, in the backyard, there has been some extension in the Pakistani or post-independence period that are already tending to demolish.

Figure 6: wooden windows details (left), backyard condition views (right) (Captured by Author, October 2021)

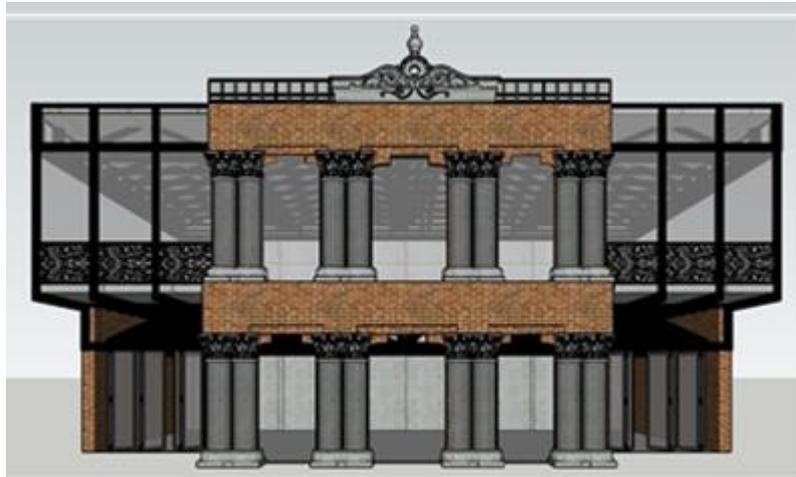
significance, at the same time, revitalize this place through retrofitting as well as generate economic opportunities creating a local community involvement. Figure 8 demonstrates a possible prototype of urban heritage has been created to depict this particular method after analysing the critical architectural elements and vulnerable components to revitalize it. It illustrates the prominent structural features and additions and addresses the structural integrity while preserving the historical significance. The major vulnerable elements found are the roof slabs and the cantilevered balconies. The walls are working as non-structural components. Therefore, a series of steel trusses might assist the floor slabs to hold and survive. Besides, the steel ribs continued along the cantilever join the trusses and lead to stable structural behaviour.

Figure 8: Prototype modeling for structural revitalization (Author constructed)
