EFFECT OF SPRAYING WATER WHILE FIRE FIGHTING ON CONCRETE STRENGTH PROPERTIES

ABSTRACT

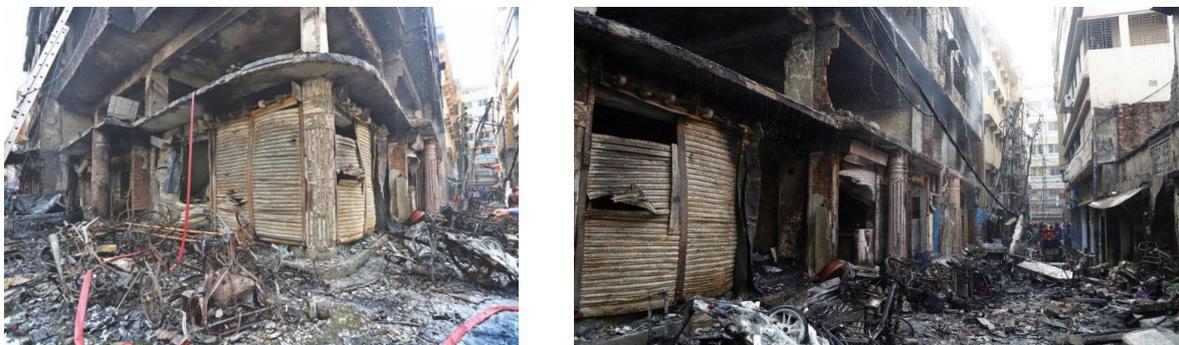
Figure 2: Concrete structures after Nimtoli fire incident (in 2010, *source-online news portal*)

In residential building, fire is generally spread out by the burning of home use items like wooden furniture, clothes etc which in fact creates cellulose fire condition. Although there are different ways to extinguish the fire, in case of any fire outbreak, people think of water to put the fire off (figure 1 d) from the closest reach source. Still sometimes the fire event in any single structure can sustain for more than a day. Even the fire fighting agencies use water to stop and control fire as shown in figure 1 f. Concrete structures can have severe damage both due to exposure of high temperature and even sudden cooling of its surfaces with water as a result of thermal shock, which causes different stresses in the concrete members. In figure 2, it is shown the structures after Nimtoli, Dhaka fire events in 2010.

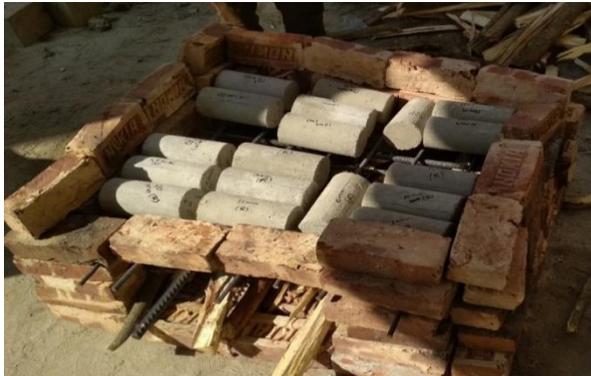
Figure 3: Burning arrangement of concrete specimens.

After 28 days of water curing, three specimens were tested for strength properties, rest were kept in room environment. Then at 90 days after casting followed by 28 days moisture curing, three specimens were tested at room temperature ($25 \pm 5^{\circ}\text{C}$) for compressive strength and splitting tensile strength respectively; and these results were considered as reference result. After that the remaining samples were burnt in cellulose fire for two hours to a maximum elevated temperature of 600°C . Then the burnt specimens were rapidly cooled in water. After 48 hours of cooling, the specimens were tested for compressive and tensile strength properties; and the results were then compared with the reference samples.

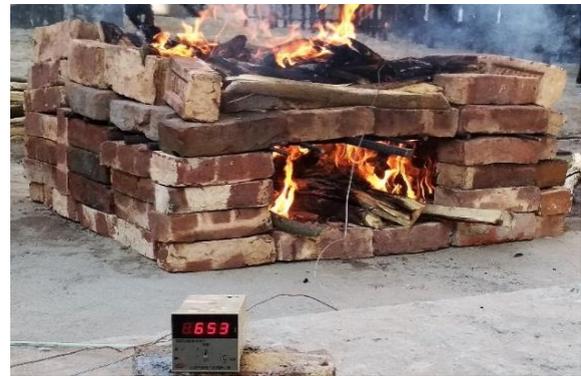
Figure 4: Burning of concrete specimens in cellulose fire.

The fire in this study was an uncontrolled cellulosic one to match with the reality. The temperature data at three different locations were recorded continuously; and a maximum of 600^oC was recorded that was lasted for about 5 minutes of its peak. After the burning of the concrete samples, no cracks or sign of damage on the surfaces was noticed. Specimens were looking healthy despite the results depicted almost 50 percent loss in strength.

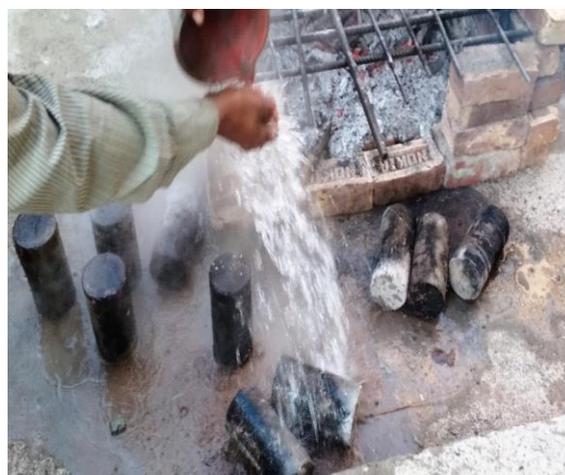
Figure 5: Rapid cooling of burnt specimens
