INVENTORYING OF BAHADDARHAT FLYOVER AND ITS IMPACT ON TRAFFIC SYSTEM

A flyover is a bridge that crosses over another road or railway for the purpose of making traffic less, which is generally constructed on road intersections to prevent congestion, accident etc. and to provide a more convenient way to navigate over the traffic. Bahaddarhat intersection is the only access which connects Chattogram city with the South-Eastern part of the country. Also roads from some in demand tourist spots such as Cox's Bazar, Kaptai, Bandarban etc. are connected with this intersection. The efficiency, safety, speed, cost of operation and capacity of road system very much depend on the intersection design. So a Grade separated intersection helps traffic to move with less interruption. Moreover, the intersecting roads are separated by different in level, thus eliminating the crossing manoeuvre. As Chattogram is the commercial capital of Bangladesh, Bahaddarhat flyover intersection plays an important role as a transporting agent among Kaptai, Coxs Bazar, Bandarban, Rangamati and Chattogram city. In order to inventory the Bahaddarhat Flyover and its traffic system, the existing geometric elements of t

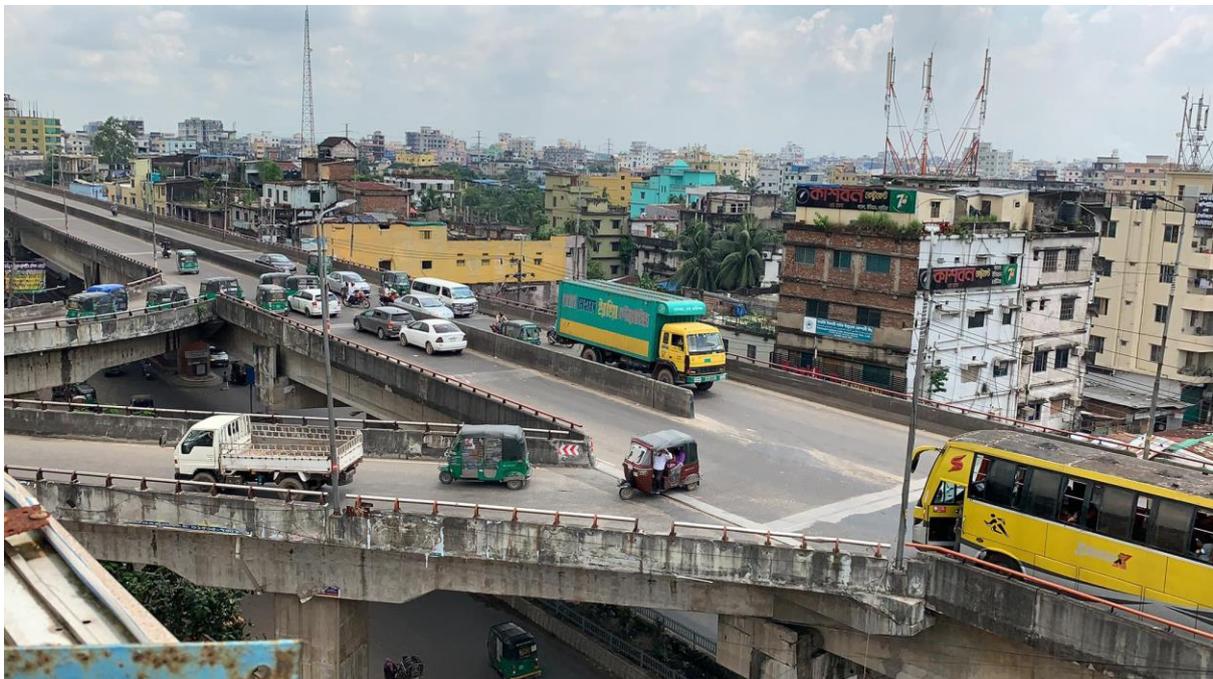
A flyover is a type of grade separated intersection that allows uninterrupted vehicles movement that were previously in conflict at grade intersection, interchanges are made up of several overpasses (Maji, 2015). Sometimes flyovers can't fulfill its purposes due to some lacking of planning perspectives. A heterogeneous mixture of vehicles from different parts of the country including Chattogram, especially bus, truck, lorry, car, motor bike, mini bus, pick-up, three-wheeler along with some non-motorized vehicles shift through this intersection. Surrounding of this intersection has generally residential and commercial installations. So, traffic volume at this intersection sometimes crossed its capacity which leads to create congestion during peak hour. In general, traffic congestion on transport networks is a state that happens due to the increase in use and is measured by speed drops, increase in travel times and vehicular queuing. The Highway Capacity Manual (HCM) has introduced the standard of a road under different operating characteristics and traffic volume. When capacity gives a quantitative measure of traffic, it tries to give a qualitative measure. As a solution of this problems, Bahaddarhat flyover was constructed by Chittagong Development Authority (CDA). In line with strategic transport plan, flyovers have been constructed around Chattogram city with the aim of improving traffic jam conditions. The huge number of vehicles along with the non-motorized vehicles make the traffic system poor in different roads of Chattogram city. Due to mitigate these problems, government has built four flyovers to enhance the mobility and ensure the trustable transportation solution according to them. Among them, Bahaddarhat flyover is one and it was inaugurated in October 12, 2013. The operating condition of existing flyover has been shown in Fig 1.

Figure 1: Bahaddarhat Flyover Intersection, Chattogram

the Eastern leg goes towards the tourist district Cox’s Bazar. The location of the study area is also shown in Fig 1.

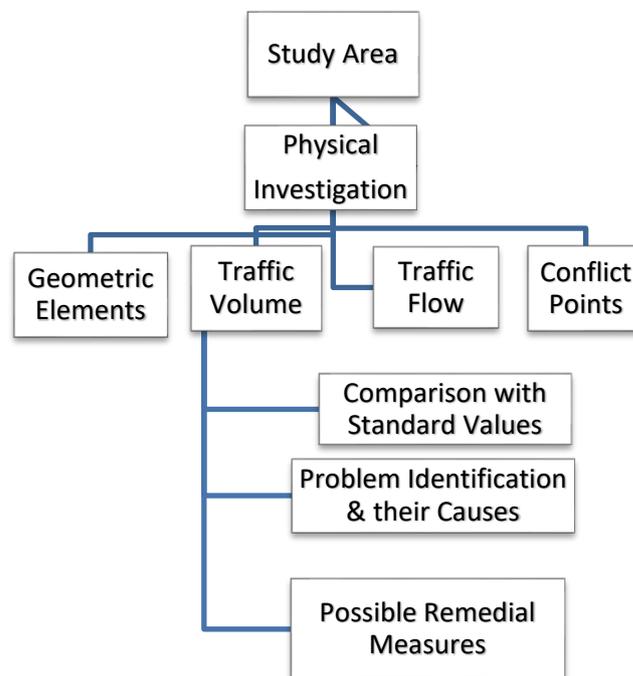
The present study has been conducted according to the following steps which are presented in the Fig-2 as flow diagram.

Figure 2: Work Flow Diagram of the Present Investigation

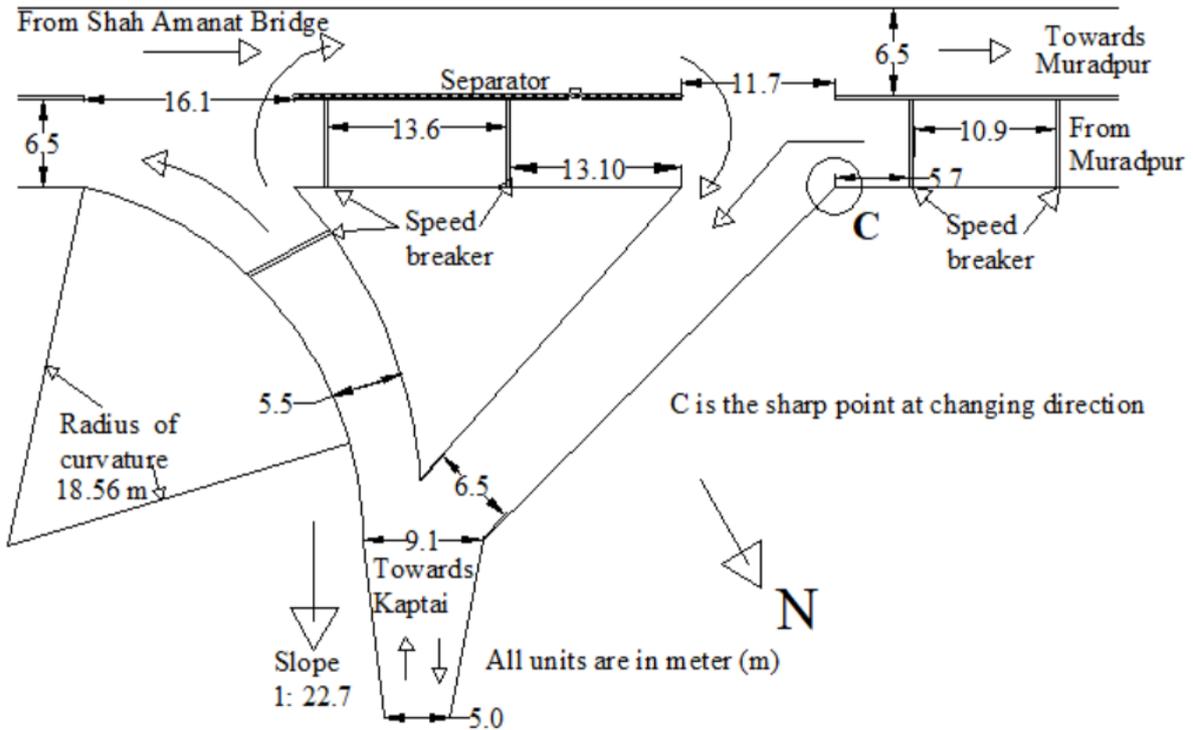
The geometric elements of the flyover intersection have been measured physically which is shown in Fig.3 and these elements have been compared with IRC (1976) standard, shown in Table 1.

Figure 3: Existing Geometric Elements of Bahaddarhat Flyover

From Table 1, it is seen that the width of the various flyover legs are less than that of the standard width of carriageway and hence eventually congestion occurs over the flyover. Moreover, from Fig 3, it can be observed that (point C) there is a sharp point that can not be desirable at changing direction. It must include a horizontal curve at this C point. Since there is no curve, it may occur any type of accident.

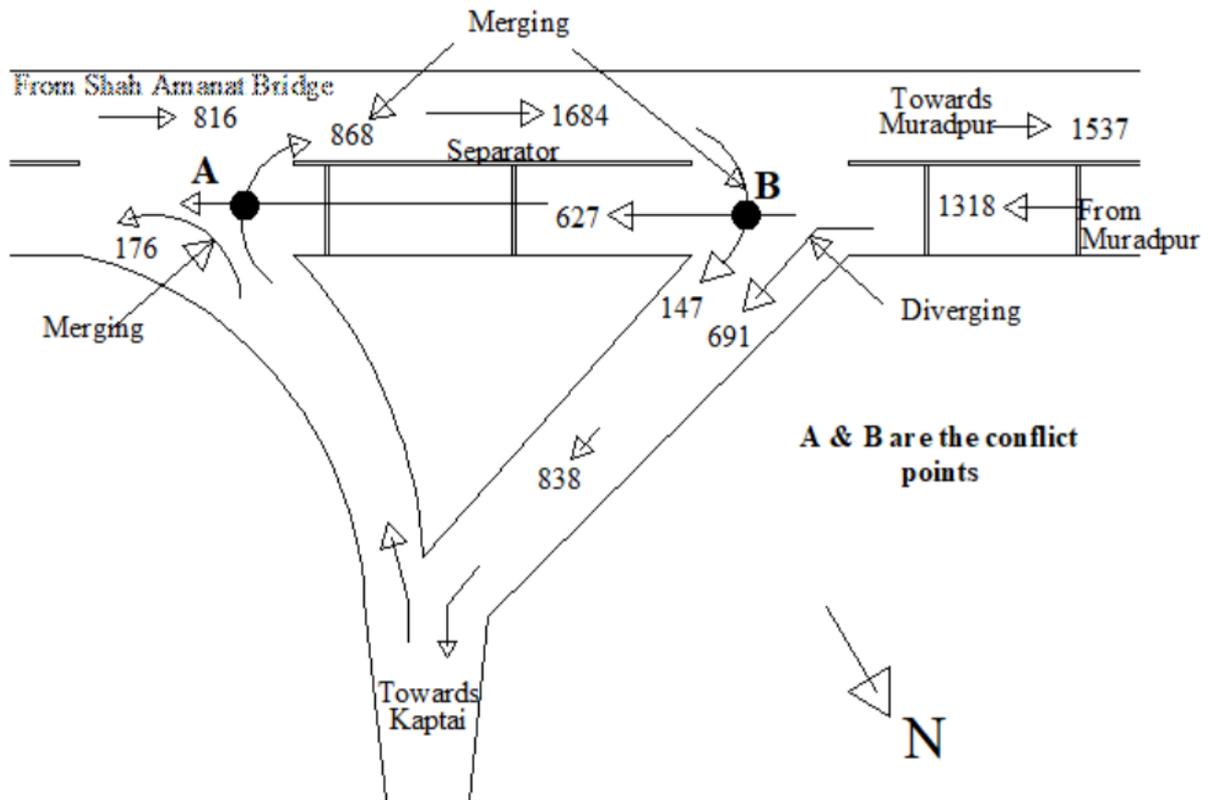
For the present traffic volume, a video camera has been provided at the top of the intersection during the peak hours consecutively for 7 days. Average traffic volume in PCU per hour alongwith traffic flow composition for different type of vehicles have been provided in Table 2 which are also depicted in Fig 4. Total PCU values also PCU factors as per RHD (2005) have been shown in Table 2.

Figure 4: Traffic Volume Distribution at peak

From Fig 4, it can be seen that two conflict points A and B have been observed on the flyover intersection. Which are not desirable. Traffic volume from Muradpur to Shah Amanat bridge i.e. 627 pcu/hr conflicts with the volume 147 pcu/hr coming from Shah Amanat bridge direction to the right turning towards Kaptai. So for this reason, a conflict point B is created there. Similarly, Traffic volume 627 pcu/hr from Muradpur to Shah Amanat Bridge creates another conflict point A with the volume 868 pcu/hr coming from Kaptai direction.

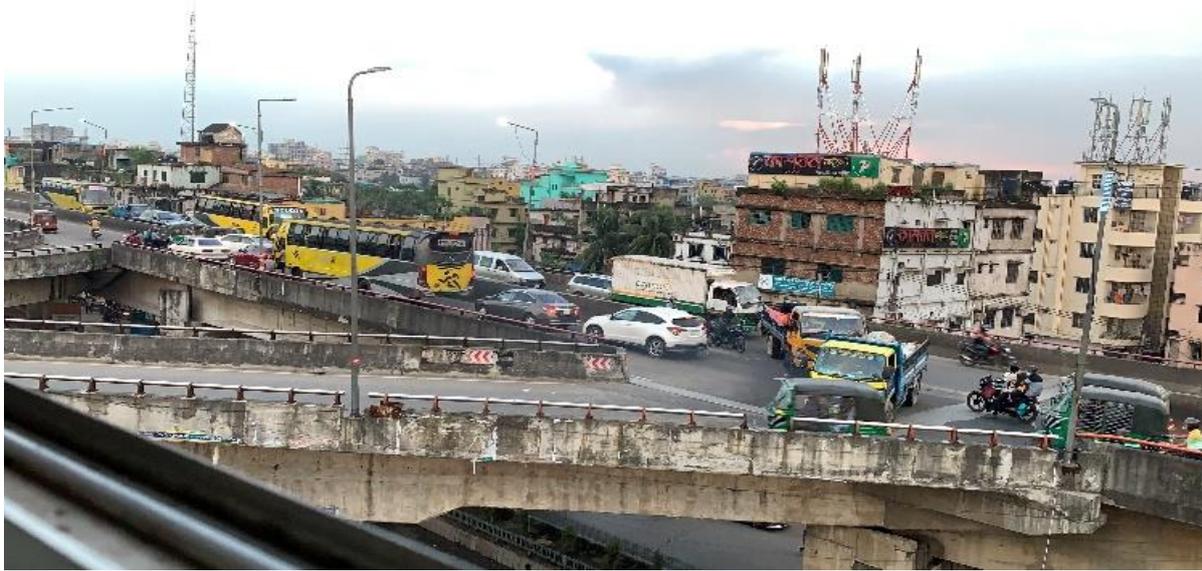
From Table 3, comparing existing traffic capacity with the standard values (H.M.S.O., 1966), it has been found that existing capacity exceeds the standard capacity. So the different heavy vehicles like truck, bus when they move together side by side, they can't move easily. That's why frequently traffic jam and head to head collision may occur on the intersection. Such type of example at peak hour can be seen from Fig 5.

Figure 5: Frequent traffic jam on the flyover

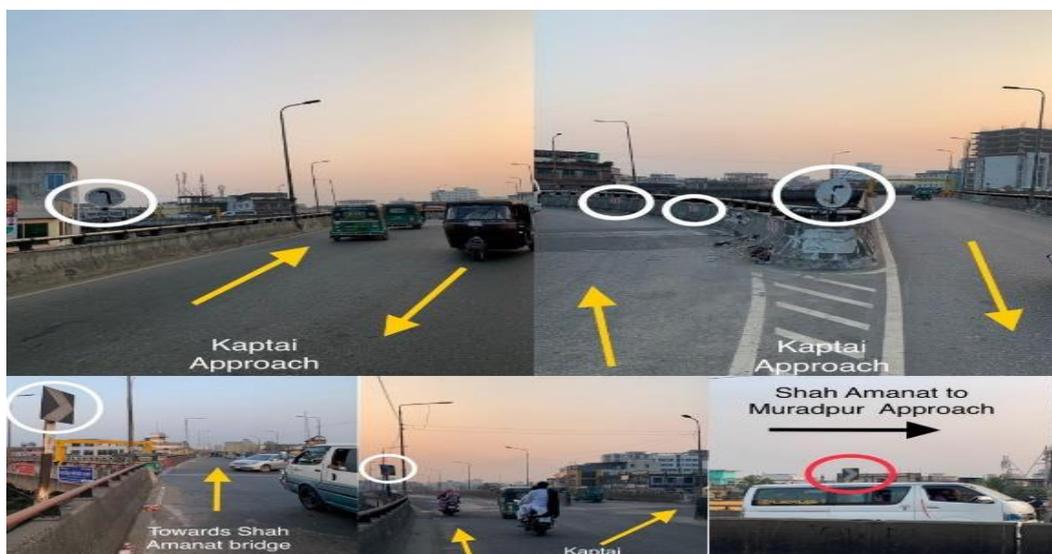
While observing traffic control devices over the flyover, direction signs, some pavement markings are observed but they may not be clearly visible specially after evening. Also there is no prohibitory sign, speed limit sign etc. over the flyover which are very essential for smooth traffic regulation. Direction signs & some pavements markings on the flyover are shown in Fig 6.

Figure 6: Direction signs on the flyover
