## **GEO-BAGS EFFECTS ON MEANDERING SECTION AGAINST BANK EROSION: A CASE STUDY OF DHARLA RIVER**

The objective of the study was to verify the effectiveness of geo-bags as river bank erosion control when it was used at the meandering section of Dharla (Flashy river). In this regard, geo-bags (250 kg) were dumped at the meandering section of Mogalbasha union when the water level started to touch the flood level during rainy season (after June 25<sup>th</sup>, 2020) and river bank erosion started. The quantity of geo-bags dumped were 60 nos. per meter against cement concrete blocks (according to Bangladesh Water Development Board design, dumping volume was 10 cum per meter). The photographic images of river bank shifting and water flow path of the river were collected. The Reduced level (RL) data were measured and reconnaissance survey was also done. When river bank erosion started at Mogalbasha union, geo-bags were dumped 60 nos. per meter in launching apron and maintaining a slope of 1: 2.5 (geo-textile filter cloth was used below geo-bags on slope) as emergency bank protection work. The river bank erosion was stopped after dumping the geo-bags. At the end of December 2020, it was

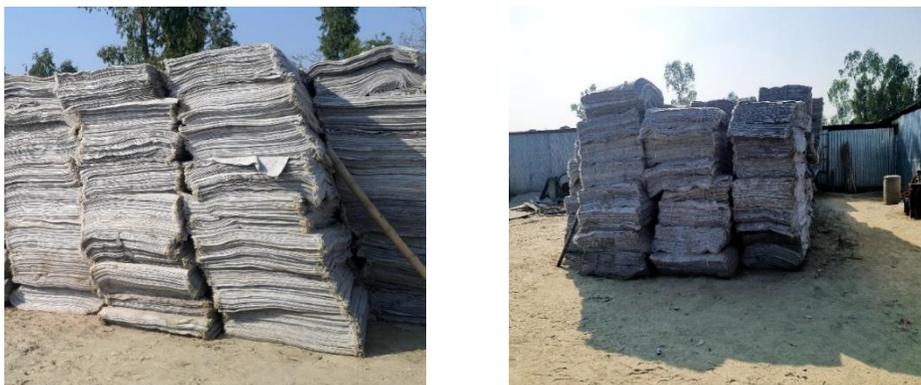
Empty geo-bags of different sizes and capacity were supplied at work site, making the bag with standard geo-textile fabric (97% Polypropylene fabric with 3% additives, mass: 400gm/m<sup>2</sup>, unit weight: 855 Kg/m<sup>3</sup> to 946 Kg/m<sup>3</sup>). Figure 3 shows that empty geo-bags were stored in a place before dumping of geo-bags on the launching apron. The inner size of each geo-bag was 1200mm x 950mm and the outer size was 1250mm x 1000mm. The geo-fabric thickness was greater than 3 mm. Filling volume of geo-bag was 0.1664 cum and the weight capacity was 250 kg.

Figure 3: Empty geo-bags

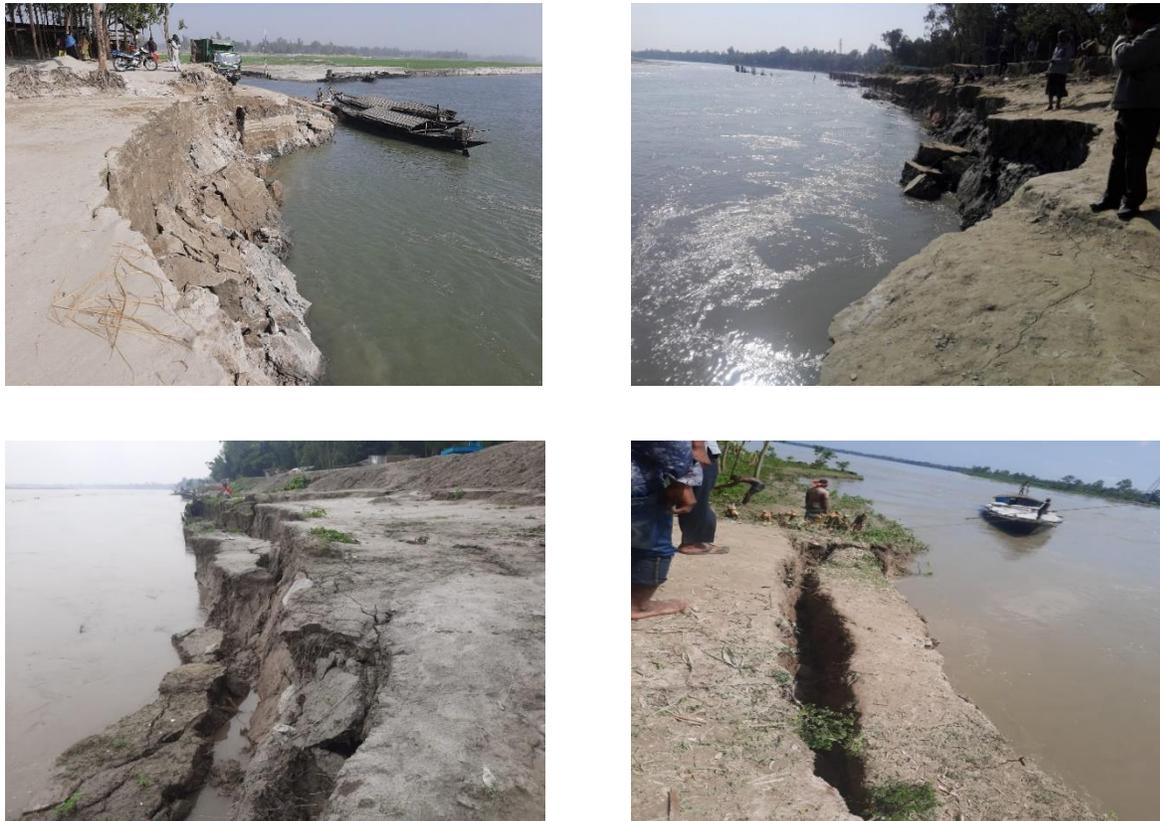
Geo-bags (250 kg) were dumped in the launching apron when the water level started to touch the flood level (after June 25th, 2020) and river bank erosion started. Figure 4 shows the river bank erosion situation when the water level of the river was started rising. Figure 5 (a) shows the sloping procedure. A slope of 1:2.5 was maintained. Geo-filter cloth was used before dumping of geo-bags (Figure 5 (b)). Figure 6 shows dumping of geo-bags. Empty geo-bags were filled with sand having FM 1-1.5. The quantity of geo-bags dumped were 60 nos. per meter according to Bangladesh Water Development Board (BWDB) design requirements.

Figure 4: River bank erosion images

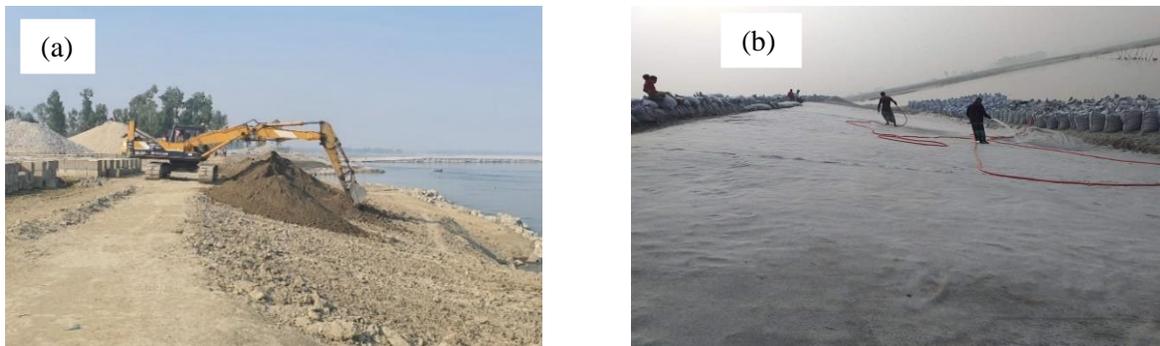
Figure 5: (a) Sloping procedure and (b) Geo-filter cloth for dumping of geo-bag

When river bank erosion started at Mogalbasha union, geo-bags were dumped 60 nos. per meter in lurching apron maintaining a slope of 1: 2.5 (geo-textile filter cloth was used below geo-bags on slope). The river

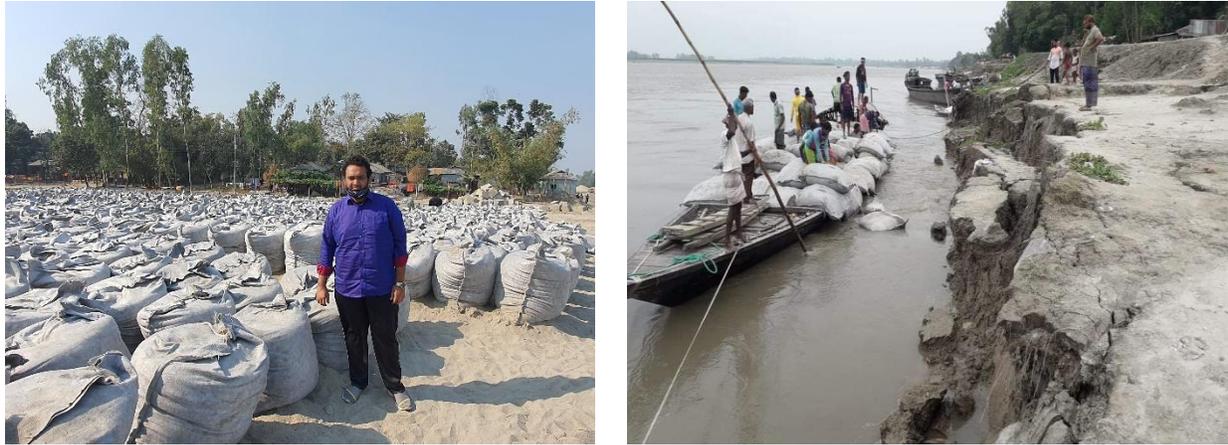
Figure 6: Dumping of geo-bags

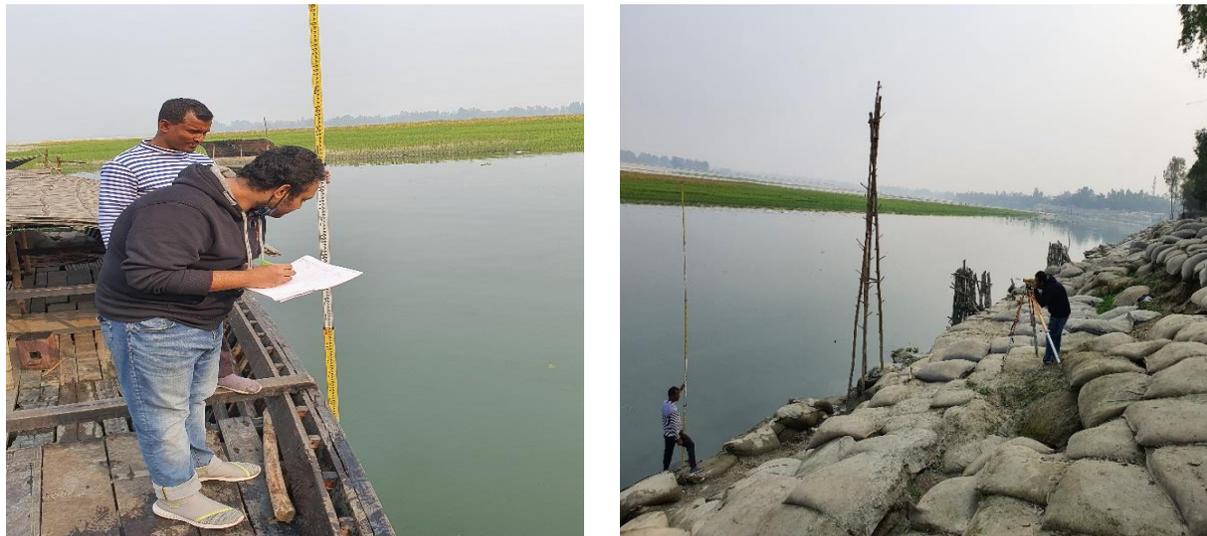
In this study, RL was measured at the section Ch 39+850 km and Ch 40+050 km (Figure 2). The RL of the water surface was taken at those sections before geo-bag dumping (after 15th March, 2020) and after geo-bag dumping (after December 15th, 2020). Figure 7 shows the procedure of taking RL value which was taken after 15th December, 2020. Moreover, reconnaissance survey was also conducted for getting overview about the morphological change of the river.

Figure 7: Measurement of RL from the study area

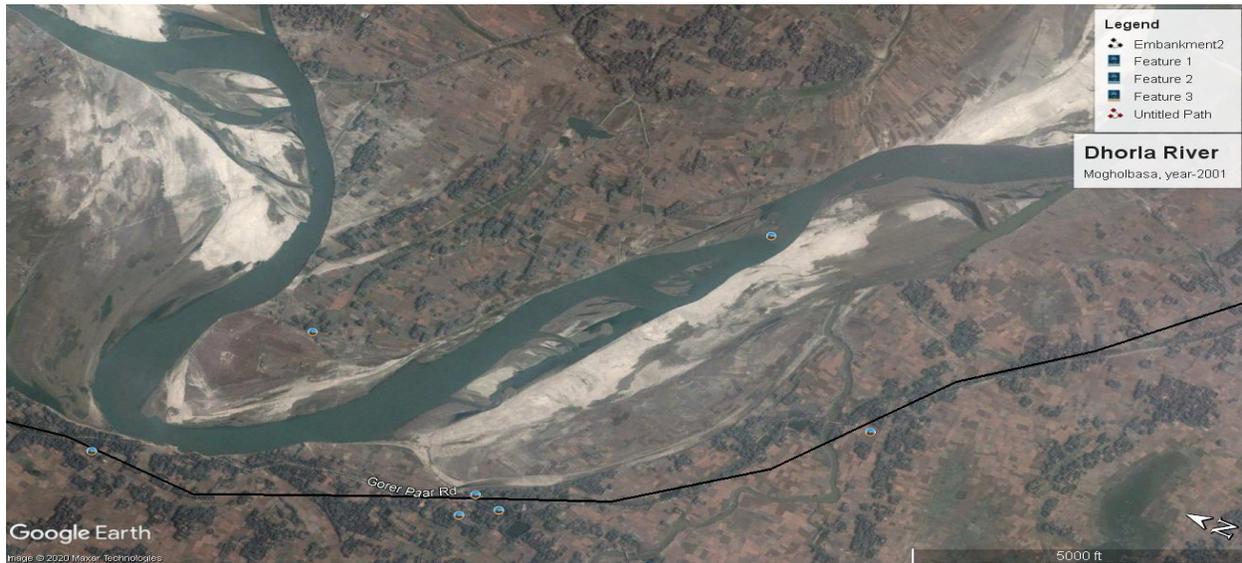
Due to the development of new char and chute channel, the flow path of river was deviated and a change in the river morphology was noticed. To get a clear sight about the morphological change of the river, satellite images of Dharla river in Mogalbasha union were collected from google earth in the year of 2001, 2014 and 2020. Figures 12, 13 and 14 shows the satellite images of the river in the year of 2001, 2014 and 2020 respectively. In both the three figures, the black line represents pucca road. Apparently, from the Figures 12, 13 and 14, it has been noticed that the river morphology is changing over the years.

Figure 12: Satellite image of Dharla river in Mogalbasha union in the year 2001

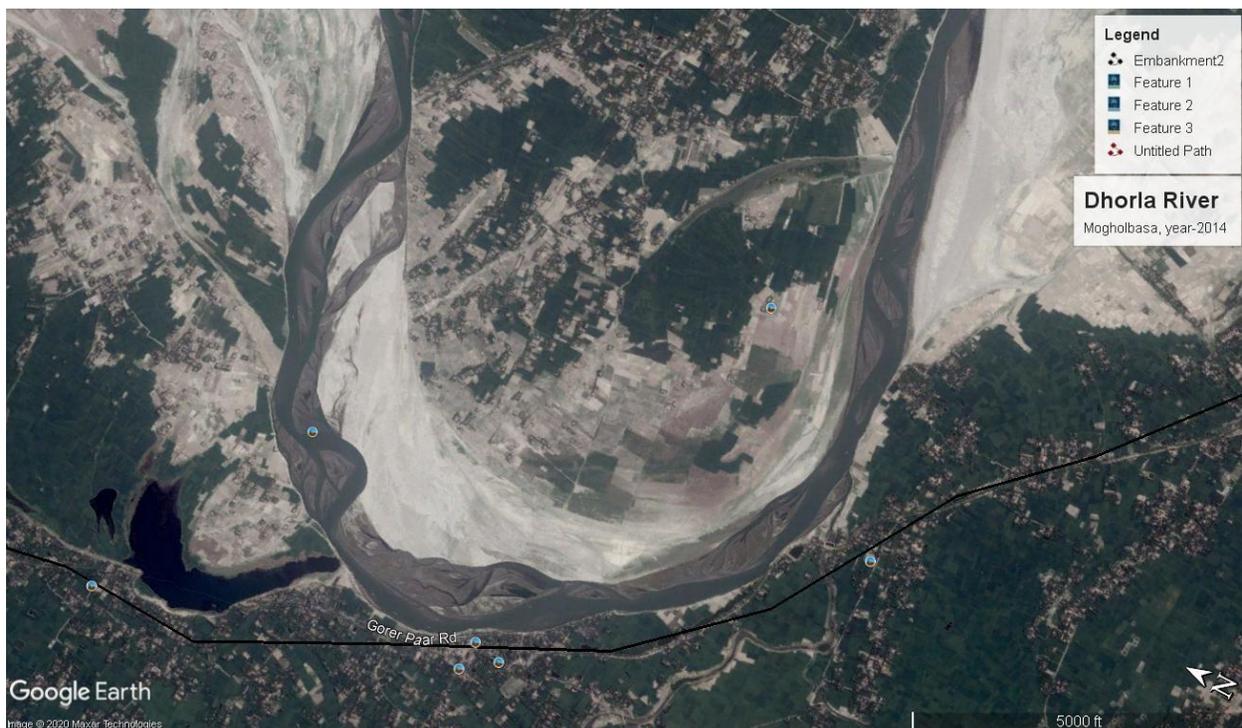
Figure 13: Satellite image of Dharla river in Mogalbasha union in the year 2014

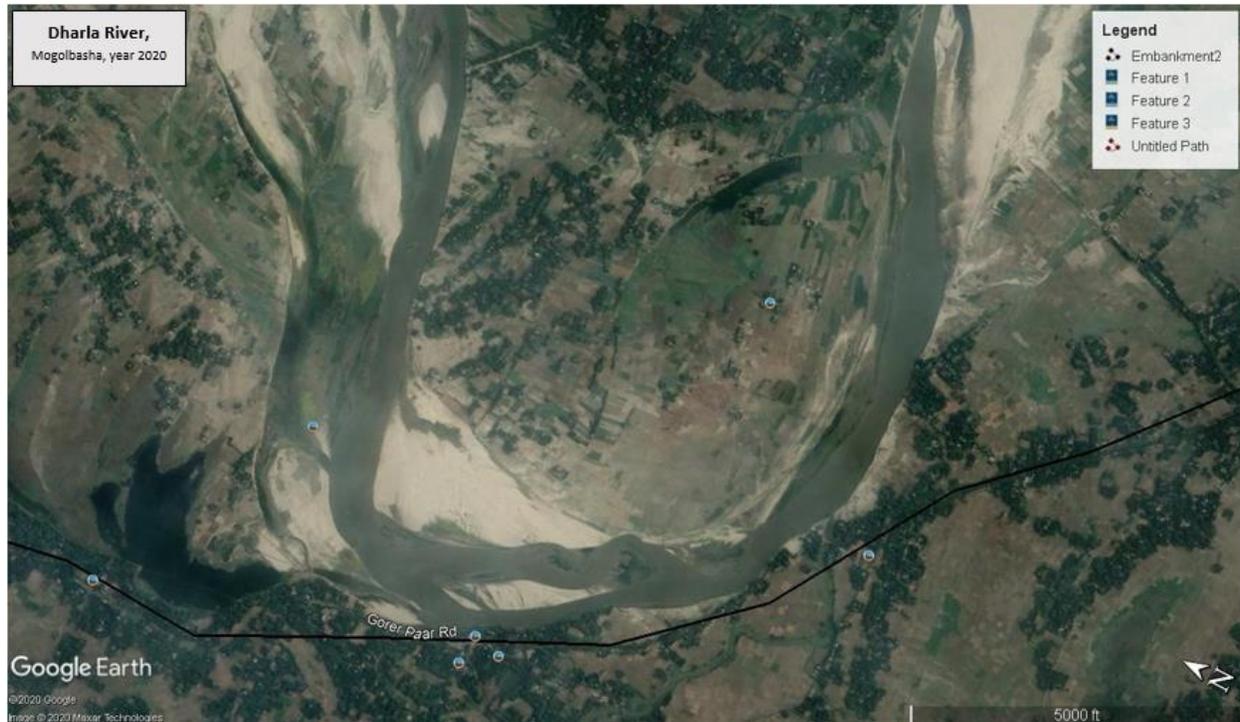
Figure 14: Satellite image of Dharla river in Mogalbasha union in the year 2020
