## A STUDY ON STRUCTURAL RISK ASSESSMENT AND REHABILITATION OF AN EXISTING RCC INDUSTRIAL BUILDING IN BANGLADESH

### ABSTRACT

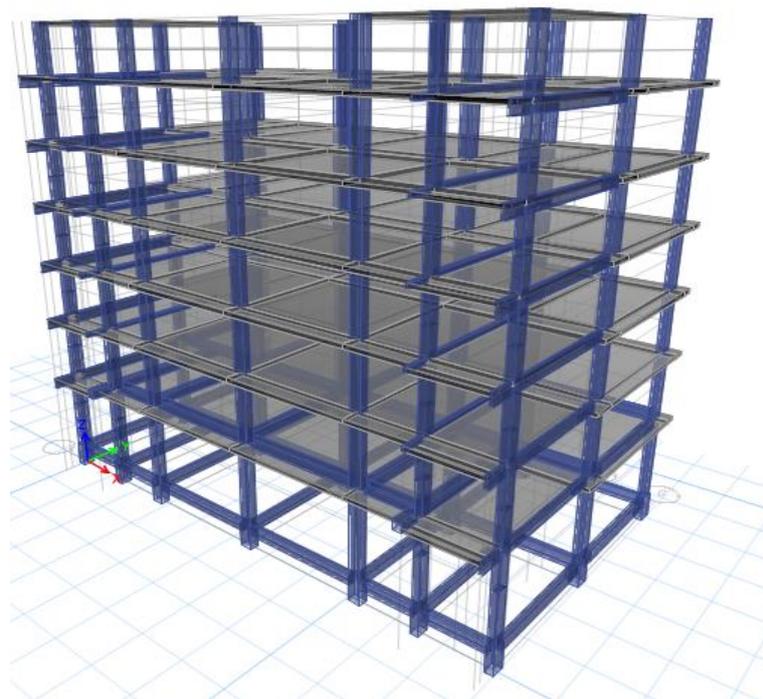
Figure 5: 3D Finite Element Model of the 6 storied RCC Industrial Building

After as built structural and materials data collection a number of analyses were used to assess the response of the foundation for the Structure. The main design model was developed using a Finite Element (FE) program ETABS. Soil is considered as continuum medium. While modelling, base support was considered as fixed. Applied as a body load to the structure foundation elements, in a direction to coincide with the appropriate wind action assumed. Floor slab was considered semi-rigid diaphragm and modelled as shell elements. Stiffness is modified. Membrane stiffness was used full scale, while bending stiffness almost ignored. Finite element structural model was done considering actual as built condition. Figure 5 shows the three-dimensional finite element model of this structure. Demand capacity ratio of steel members was collected from design software ETABS.

The Existing structural system of this building was modelled using ETABS Software considering dead load, live load, wind load and earth quake load according to BNBC-2006 and NTPA load combination.

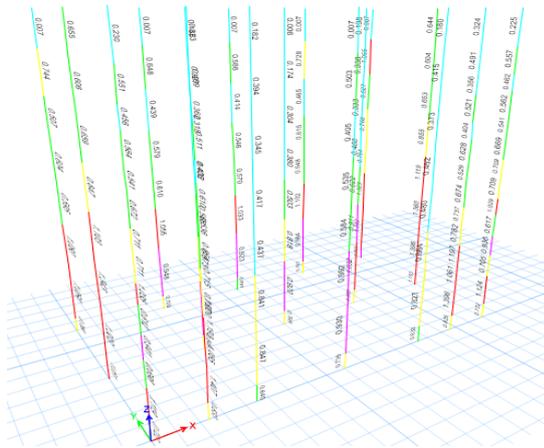
Figure. 6: Demand capacity ratio of column

Structural members which has p-m-m ratio more than 1 is considered as inadequate. Figure 6 shows the demand capacity ratio of columns and figure 7 shows the column interaction diagram for axial and bending moment. Table 3 reveals the evaluation of column capacity.

Demand capacity ratio of steel column			Remarks
Grid id	Members name	P-M-M Ratio	
01-a, b, c, d & e	Column (Sizes 12”X20” & 20” X20”)	1.11, 1.40, 0.84, 0.99, 0.84, 1.19, 1.12	Red marked values which contain greater than 1 considered as Unsafe column marked values which contain greater than 1 considered as Unsafe column
02-a, b, c, d & e	Column (Sizes 16”X20” & 20” X20”)	1.34, 0.99, 0.92, 1.04, 1.39	marked values which contain greater than 1 considered as Unsafe column
03-a, b, c, d & e	Column (Sizes 16”X20” & 20” X20”)	1.08, 1.05, 1.03, 1.10	marked values which contain greater than 1 considered as Unsafe column

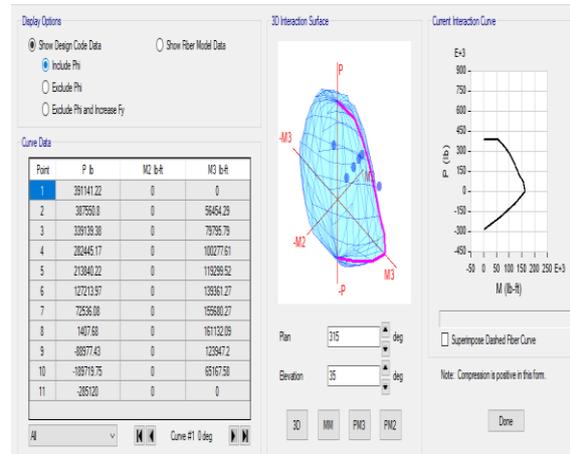
Figure. 7: Column interaction diagram

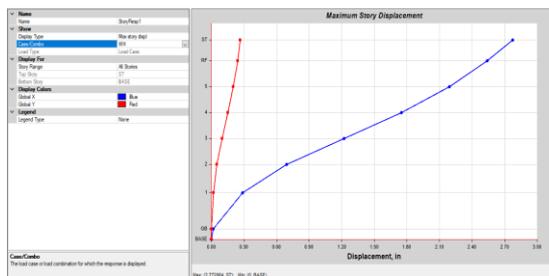
Figure 8: Maximum displacement

From ETABS the values of deflection given by the structure was collected. From the deflection checked it was found that the structure is failed in deflection. Floor Drift of this existing structure within the allowable limit. Maximum displacement in Y direction against wind load while Maximum displacement in X direction against seismic load. Figure 8 and 9 show the maximum displacement against wind load and maximum drift against earthquake load respectively. Table 4 indicates the evaluation of serviceability (BNBC- 2006, table 6.6.4 and chapter 1.5.6).

Evaluation of story displacements					Evaluation of story drift				
Direction	Load	Developed story displacement (inch)	Allowable story displacement (inch)	Remarks	Direction	Load	Developed story drift	Allowable story drift	Remarks
Y	Wind Load	4.55	1.995	Unsafe	X	Seismic	0.016	3.19	Safe

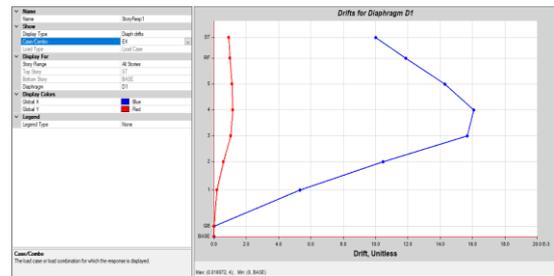
Figure 9: Maximum drift

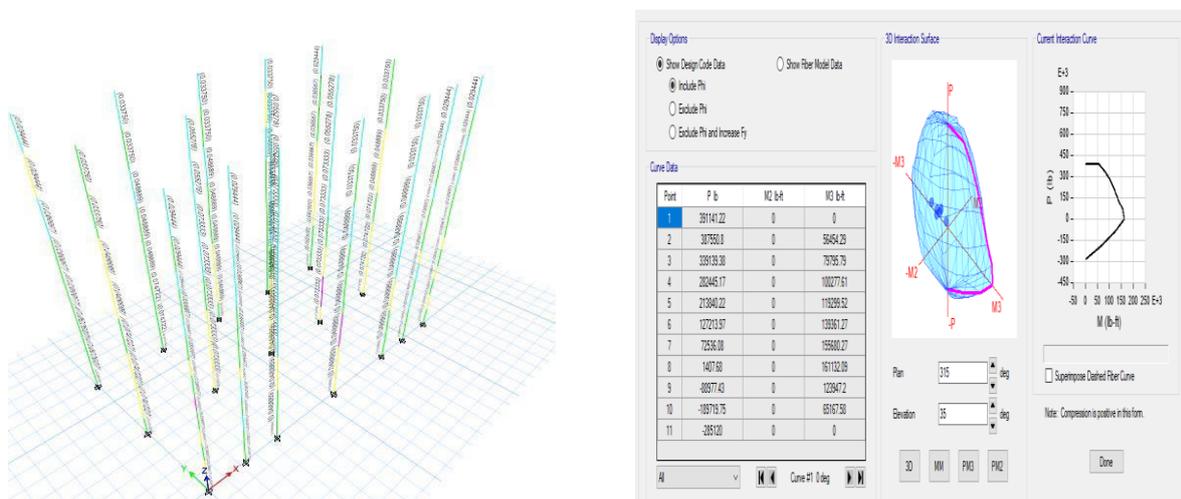
Figure. 10: Demand capacity ratio of column and interaction diagram after retrofitting

Model of retrofitting industrial building was done by modification of existing model considering BNBC-2006 load combination for RCC structure. Earthquake load also revised after retrofitting. After retrofitting analysis all structural members were found adequate against all kind of lateral load and gravity load. Table 5 shows the demand capacity ratio, ratio of all columns found under 1.00. Figure 10 shows the demand capacity ratio of columns and column interaction diagram for axial and bending moment after concrete jacketing of existing column. Table 5 reveals the evaluation of column capacity.

Demand capacity ratio of steel column			Remarks
Grid id	Members name	P-M-M Ratio	Red marked values which contain greater than 1 considered as unsafe column
01-a, b, c, d & e	Column (Sizes 28”X20” & 20” X20”)	0.59, 0.79, 0.64, 0.79, 0.54, 0.87, 0.72	marked values which contain greater than 1 considered as unsafe column
02-a, b, c, d & e	Column (Sizes 28”X22” & 20” X20”)	0.64, 0.54, 0.54, 0.67, 0.77	marked values which contain greater than 1 considered as unsafe column
03-a, b, c, d & e	Column (Sizes 28”X20” & 20” X20”)	0.76, 0.88, 0.57, 0.65	marked values which contain greater than 1 considered as unsafe column

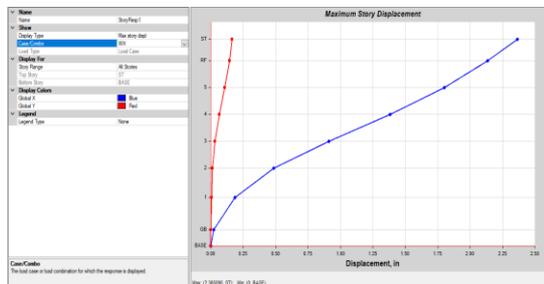
Figure 11: Maximum displacement

From ETABS the values of deflection given by the structure was collected. From the deflection checked it was found that the structure is safe in deflection after retrofitting. Floor Drift of this modified structure within the allowable limit. Maximum displacement in Y direction against wind load while Maximum displacement in X direction against seismic load. Figure 11 and 12 show the maximum displacement against wind load and maximum drift against earthquake load respectively. Table 6 indicates the evaluation of serviceability (BNBC- 2006, table 6.6.4 and chapter 1.5.6).

Evaluation of story displacements					Evaluation of story drift				
Direction	Load	Developed story displacement (inch)	Allowable story displacement (inch)	Remarks	Direction	Load	Developed story drift	Allowable story drift	Remarks
Y	Wind Load	0.89	1.995	Safe	X	Seismic	0.014	3.19	Safe

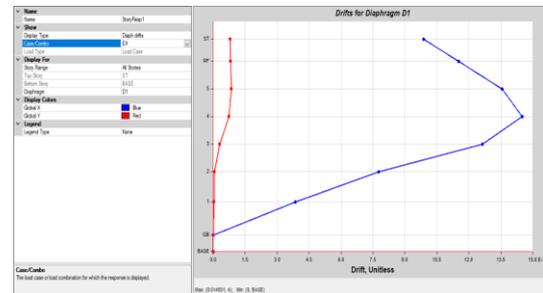
Figure 12: Maximum drift

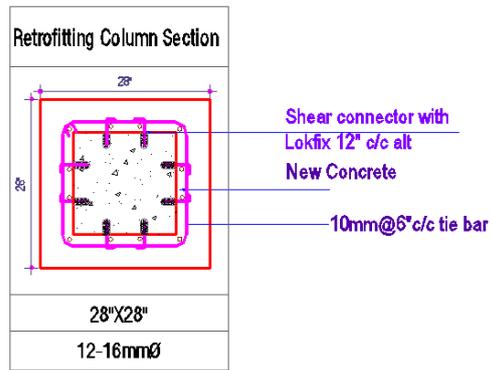
Figure 13: Drawing of Column Jacketing

After analysis of retrofitting structural model all structural members were found adequate against all types of lateral loads and gravity loads then retrofitting structural drawing was done according to retrofitting model for retrofitting construction of the existing building. Retrofitting construction was performed according to retrofitting structural design and drawing. Removed the RCC concrete cover of the column and expose all the longitudinal bars. Installed new rebars on all faces of Column using appropriate epoxy Grout. Provided sufficient anchoring of new concrete with the old concrete. Inserted new rebars on the corners of the column and connect with existing bars by welded Bent Bars. New bars should be provided in the corners to avoid puncturing the beams. For jacketing, concrete strength should be more than existing column concrete strength, or at least equal to it. Figure 13 shows the drawing of retrofitting column section while figure 14 reveals the rebar arrangements of beam column joint area. The rehabilitation of existing building was done for this study that will not make any hamper of working environment and space. Figure 15 shows the working procedure during column jacketing and figure 16 shows the photos after completion of retrofitting work.

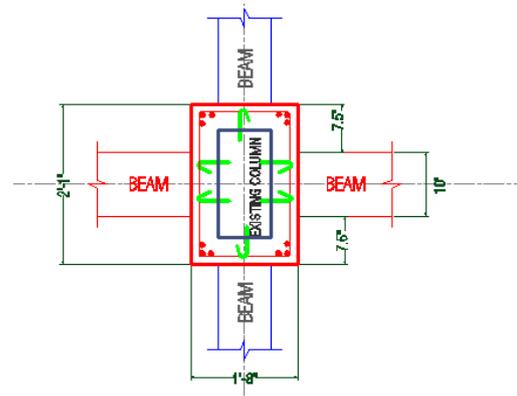
**REBAR ARRANGEMENTS IN BEAM COLUMN JOINT AREA**

Figure 14: Beam column joint area.

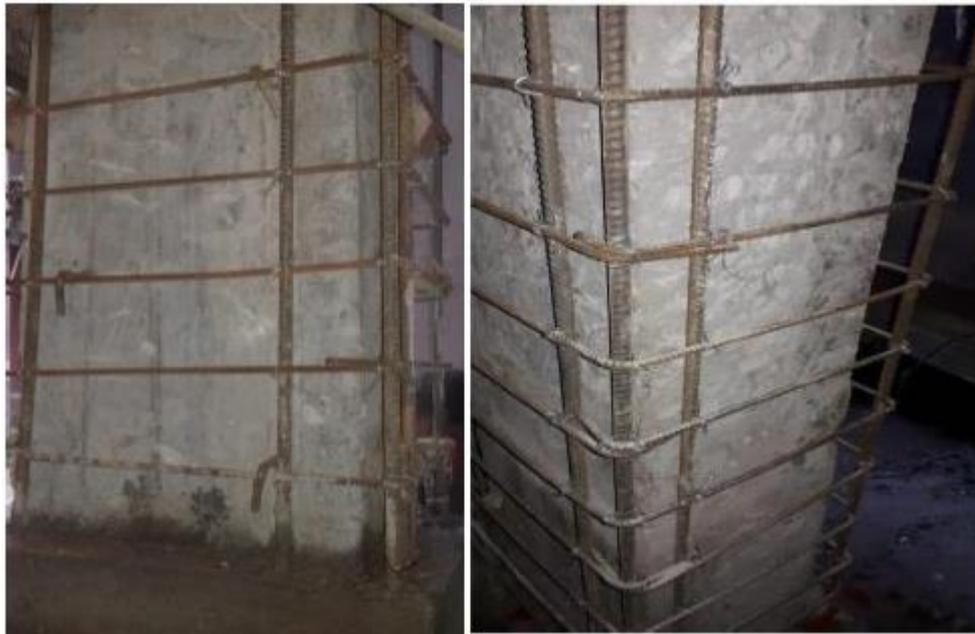
Figure 15: Photos of RCC column jacketing construction.

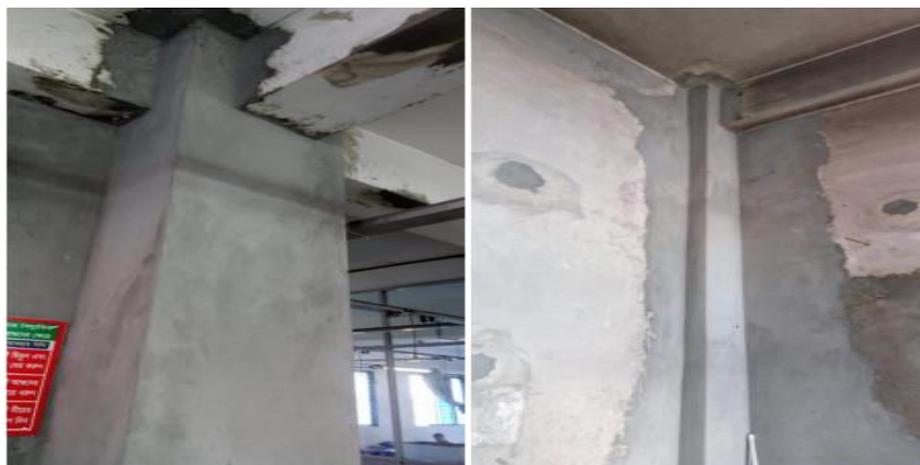
Figure 16: Photos of column after retrofitting.
