## **EVALUATION OF LOW VOLUME RURAL ROAD DAMAGE IN COASTAL AREAS OF BANGLADESH**

### **ABSTRACT**

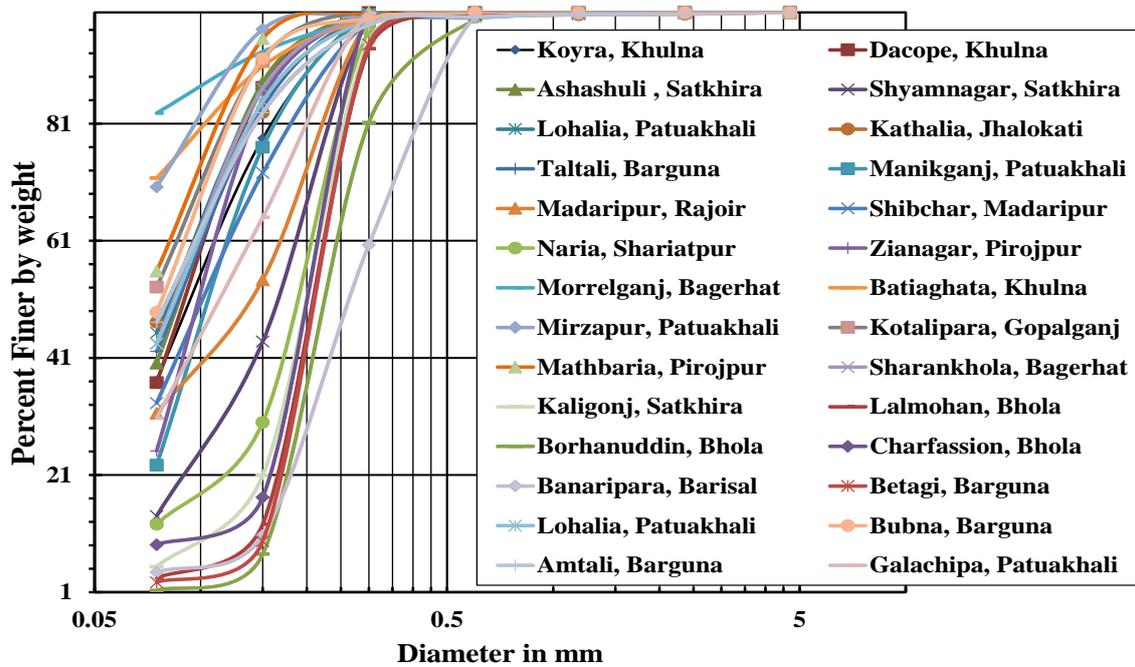
Among the 28 sand samples, 5 samples are poorly graded sand, 5 samples are sandy silt and other 18 samples were silty sand as per the Unified Soil Classification System (USCS) (Figure 4). The Fineness Modulus (FM) of 4 samples are more than 0.80, 2 samples between 0.50 and 0.80. Other samples have the FM ranged from 0.00 to 0.50. As per AASTHO, 14 samples are of group A-4, 7 samples of A-3 and of A-2-4 group 6 samples. Fines content of the sandy soil varied from 0 to 82%. Most of the sand samples did not meet the requirement of LGED specification. Due to unavailability of specified sand of FM greater than 0.80, contractors frequently use locally available very fine sand, silty sand and sandy silt in ISG and sub-base with poor compaction control. This is one of the reasons of unsustainable rural roads in Bangladesh.

Figure 3. Grain size distribution of sands used for ISG and subbase in coastal districts of Bangladesh.

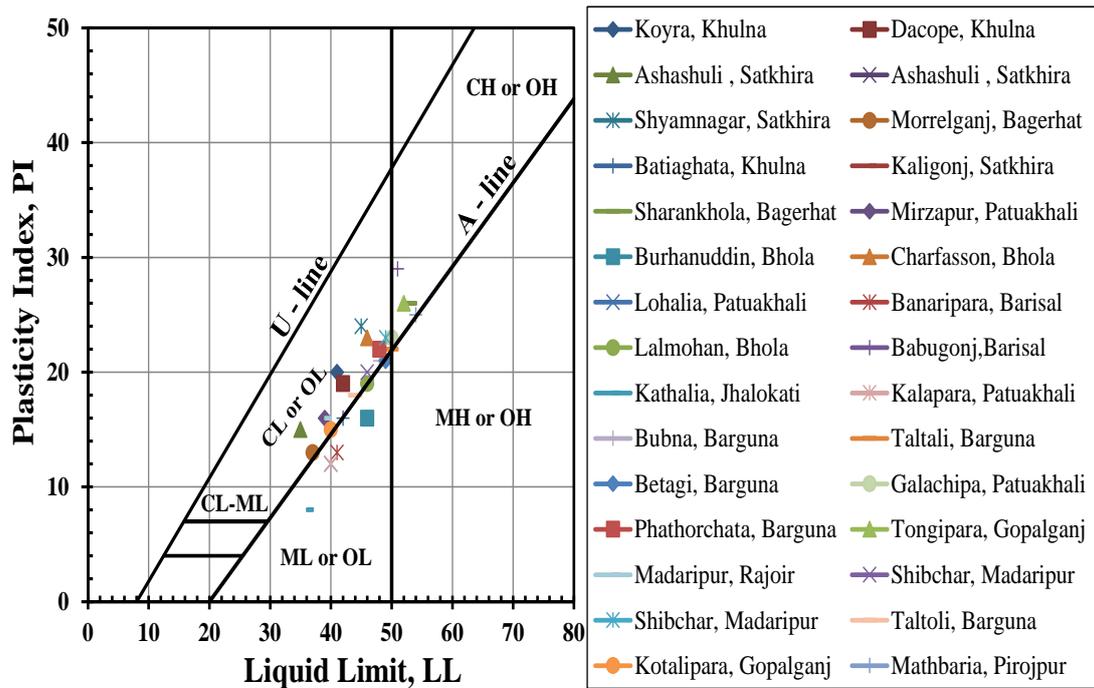
Among 28 borrow pit samples, 6 samples were silt, 6 samples were fat clay and 18 samples were lean clay (as per USCS) (Figure 4). These soils are used in widened part and shoulder of embankment without compaction. Benching and layer by layer compaction is not done in widened part. So, this is not integrated with existing embankment. As a result, shoulder and widened part of embankment is soft where vehicle runs frequently during passing over.

Figure 4: Position of borrow pit soil samples of coastal districts in the plasticity chart

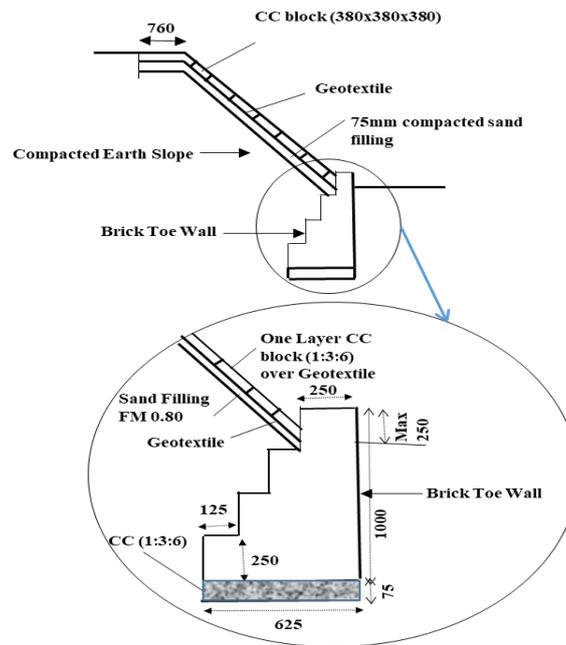
Some rural roads run along the bank of river or khal (Figure 9). This kind of road needs slope protection works for sustainable road construction. Sometimes, slope protection work is done using CC block revetment as shown in Figure 10. This is a typical design which is followed everywhere without any slope stability analysis. That is why sometimes slope failures are observed as shown in Figure 11. Limited fund of rural road construction is a reason of not doing any proper slope protection design.

Figure 10: Schematic diagram of designed slope protection.

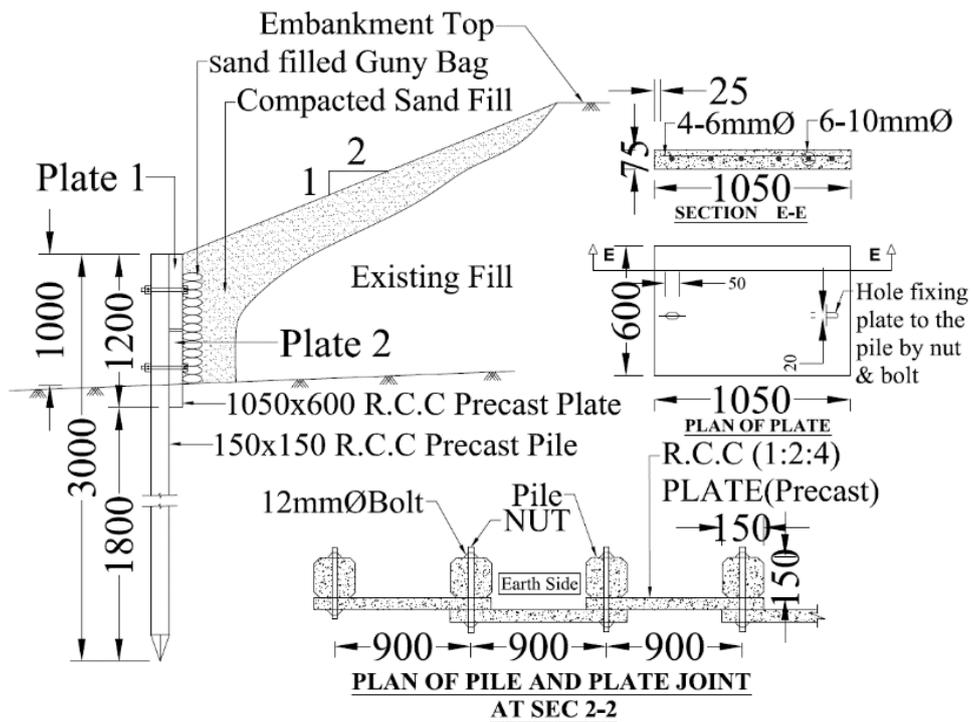
Palisading is done to stabilize the slope. In most of the cases palisading does not work properly. Figure 12 shows the design of palisading followed by LGED. Firstly, the precast piles of 3 m length are driven into the existing soft soil at a c/c distance of 0.90 m. Thereafter the RCC precast plates are hooked using nuts and bolts. After one or two years of construction the nuts and bolts become corroded and slipped from hooked piles (see Figure 13). Besides, in between two vertical RCC plates small gap exist through which the soil washed away day by day and erode the slope (Figure 13). Later this design is modified by LGED. They used cast in place plates instead of precast plates. However, this system is not stable in many soil conditions of coastal districts. The posts are inserted within the soft soil layer. Existing typical design and construction methodology of palisading need to be revised. Palisading design need to be modified with proper stability analysis.

Figure 12: A typical design of palisading implemented by LGED.

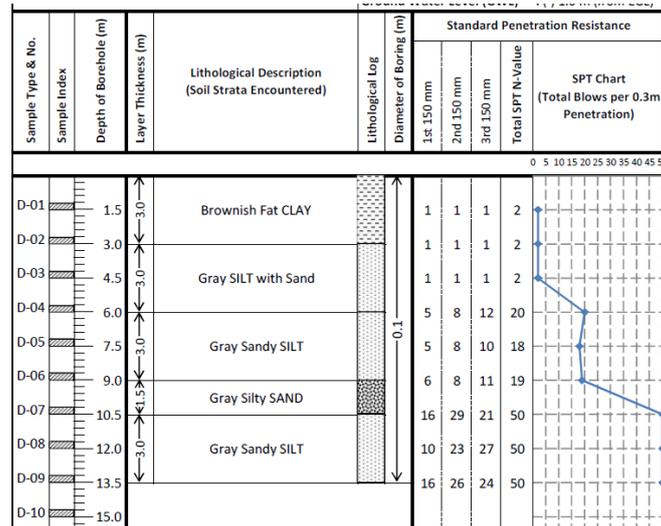
Nearly 85 percent of Bangladesh is underlain by deltaic and alluvial deposits of Ganges, Brahmaputra, and Meghna river systems (Alam et al, 1990). In the previous studies of the coastal region of Bangladesh, it was found that the sub-surface soil is soft (Kabir et al, 2000; Nath et al, 2017). At least 4-8 m soft clay exists at top layer of subsoil in coastal districts. Figure 20 shows a bore log of plot for Civil Surgeon office, Gopalganj. In another research report on “Ground Improvement on Khulna Soft Soil” revealed that more than 15 m soft clay layer exist at top of subsoil in Khulna region (AsCAP final report, 2017). The soft soils consist of silt or clay. Besides, in that region, in some places, an organic clay layer of 3-5m thickness was found. This organic layer was formed from the decomposition of mangrove vegetation of the largest mangrove forest of Bangladesh (Kabir et al, 2000). As the soils of the coastal area are soft and sometimes those are organic, settlement of the newly constructed road or widened or elevated road continues more than 10 years. This settlement is not uniform along longitudinal direction of road.

Figure 20: A subsoil bore log at Civil Surgeon Office, Gopalganj, Dhaka

When roads are constructed on this subsoil, consolidation and squeeze out of soft clay cause subsidence, cracking and rutting of constructed road. Subsoil investigation should be mandatory for road project in coastal areas. Special attention should be given in the planning and design phase of road projects. Figure 21 shows the settlement of road on soft soil. In the both sides of the road fish farm is full of water.

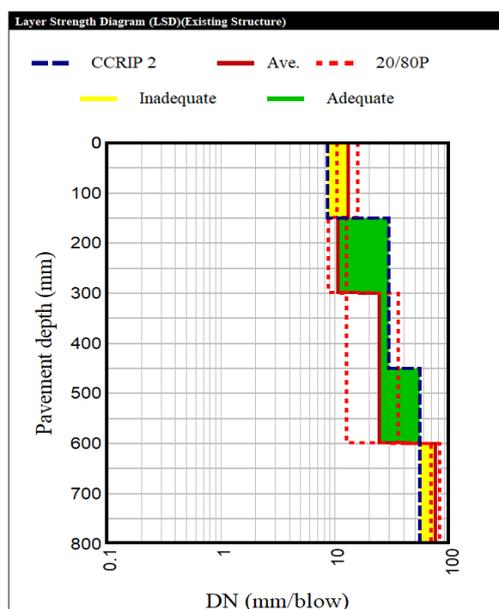
Figure 26. Analysed DCP test result (P7\_Modhupur, Khulna): Layer strength diagram

A digital moisture meter was used to measure moisture content of the subbase and ISG after making a small hole on road pavement. Later it was filled with concrete. Moisture contents of roads were between 14 and 18 percent for subbase and ISG. In the shoulder the moisture content was more than 50 percent. The DCP test data were analysed by using the AfCAP LVR-DCP software (A software developed by Africa Community Access Program). In Figure 26, adequacy of each layer is checked by comparing with maximum recommended DN (mm/blow) values shown in Figure 23. Adequate layers are represented by green colour and inadequate layers by yellow colour. Thus, all DCP tests data were analysed and adequacy of layers is listed in Table 1. In most of the cases, bases were found inadequate. 10 points out of 16 points on shoulder were inadequate. Some sub-bases were found inadequate and few ISG (Improved Subgrade) were found inadequate.

Rutting on road pavement may be attributed to inadequate base layer. Initiation of damage at the edge of pavement may be attributed to inadequate shoulder. Shoulder and widened part of road acts as confinement to existing road. Soft shoulder is not capable of giving confinement to pavement layers. That is why authors think that shoulder should be hard type with herring bone brick under which there should be a sub-base layer. Dumping of mud at shoulder and side slope must be avoided to make sustainable rural road.
